Failure investigation of in-flight separation of afterburner nozzle flap in a turbojet engine

A turbojet fighter experienced a separation of the afterburner nozzle flap during flight. Three mounting bolts were intended to fasten the nozzle flap assembly, but complete fracture of these bolts was the primary reason of failure. One of them was lost during the incident and two shank parts of the mounting bolts remained in the engine component. Laboratory investigation of the failed components of the nozzle flap assembly indicated that the mounting bolts were improperly installed during the last maintenance. Detailed fractographic study and metallurgical analysis focused on the fractured bolts and revealed fatigue striations with an overload dimple morphology in all fractured surfaces of the bolts. The investigation established sufficient evidence of improper installation of the primary flap assembly due to deformation of the alignment hole which inevitably resulted in higher operational loads on the bolt. It is concluded that the missing bolt had failed first, and other bolts fractured in succession in the manner of fatigue fracture. In response, preventive measures regarding inspecti

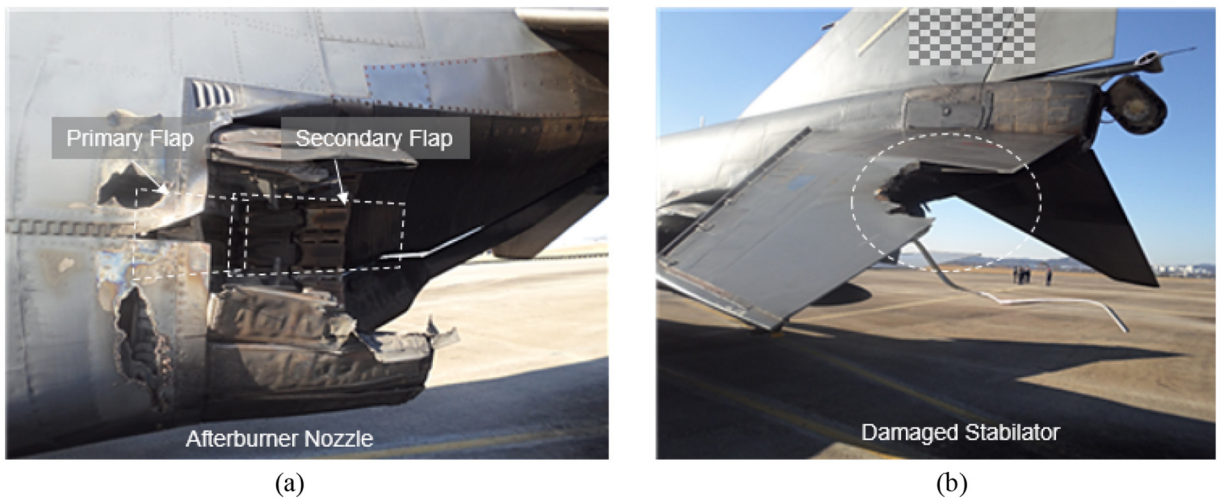
Fig. 2. (a) Damaged afterburner nozzle components and (b) stabilator.
