Sulphide stress cracking of a valve stem of duplex stainless steel

The present paper describes a failure investigation of a double disc valve stem made of duplex stainless steel 329 (UNS S32900). The valve stem which operated in moist H₂S environment at 128 °C in a heavy water plant had undergone cracking during operation. The microstructure of the stem material showed precipitates of σ -phase at ferrite/austenite boundaries and elongated oxide inclusions. The formation of σ -phase had occurred during the manufacturing stage of the stem. The crack propagation was more favourable in the ferrite phase and along the ferrite/austenite boundaries where precipitates of σ -phase were formed. It was concluded that the valve stem failed by sulphide stress cracking due to hydrogen embrittlement of ferrite phase. Recommendations to avoid such failures are also suggested.

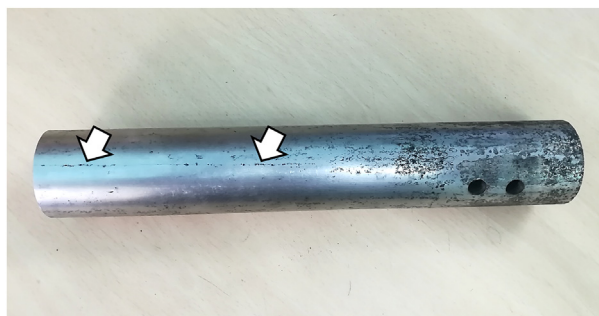
Fig. 1. The image of the failed valve stem showing corrosion attack and axial cracks (indicated by arrows) at several locations.

A double disc valve stem (diameter 62 mm) made of duplex SS 329 (UNS S32900) in a heavy water plant failed due to cracking during operation. The photograph of the failed stem is presented in Fig. 1 that shows a long longitudinal crack (indicated by arrows). There were several other cracks as well as patches of corrosion attack on the cylindrical surface of the stem. The stem was used in a moist H_2S gas environment at pH = 4 and at a temperature and a pressure of 128 °C and 19 Kg/cm² respectively. The valve stem was in service for 30 years.
