Root cause analysis of an uncommon surface defect on galvanized steel sheet

^a Research and Development, Tata Steel, Jamshedpur, India

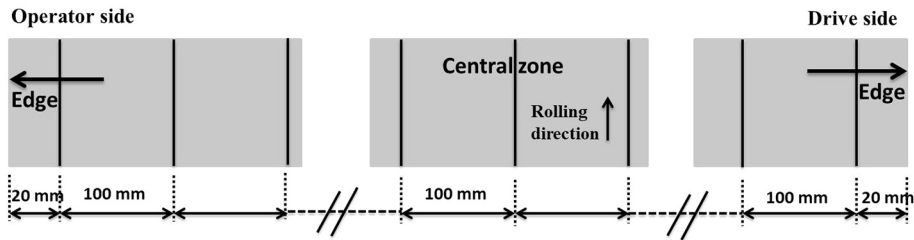
Fig. 1. Method of sampling along the width of the steel sheet.

The defect was randomly distributed on the steel sheet along the width and found almost on every steel strip at the last 10 days of every galvannealing campaign. Under visual inspection the defect looked like an indentation mark. However, it was difficult to resolve because of their microscopic nature. So, the strip was divided into number of small sections along the width and samples from every section were collected for further analysis. Due to the presence of more defects at the edges a smaller section of 20 mm was taken at the edges and the rest of the width was divided into 100 mm sections as shown in Fig. 1. Samples were collected from every section and further analysed. Several samples were collected and analysed using this methodology.
