Failure analysis of a truck diesel engine crankshaft

Xiao-lei Xu*, Zhi-wei Yu

Department of Material Science and Engineering, Dalian Maritime University, Dalian 116026, PR China

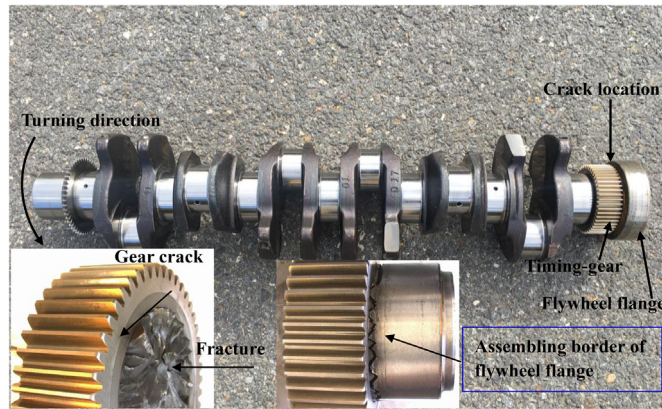
Fig. 1. Failed crankshaft in as received condition.

The as-received crankshaft assembly is shown in Fig. 1. At the crankshaft big-end, the timing-gear and the flywheel flange were coupled to the crankshaft journal. Visual inspection revealed that the fracture location was just located at the assembling gap on the journal between the timing-gear and the flywheel flange (marked in Fig. 1). The fracture was basically perpendicular to the shaft axis (seen in left inset of Fig. 1) and zigzag crack morphology was presented on the journal surface (seen in right inset of Fig. 1). It was noted that a radial crack appeared on the surface of timing-gear.
