High-temperature corrosion of a UNS K03006 steel pipe in a crude oil vacuum residue distillation unit

J. Bravo-Méndez^{a,*}, J.L. González-Velázquez^a, M.A. Domínguez-Aguilar^b,
D.I. Rivas- López^a

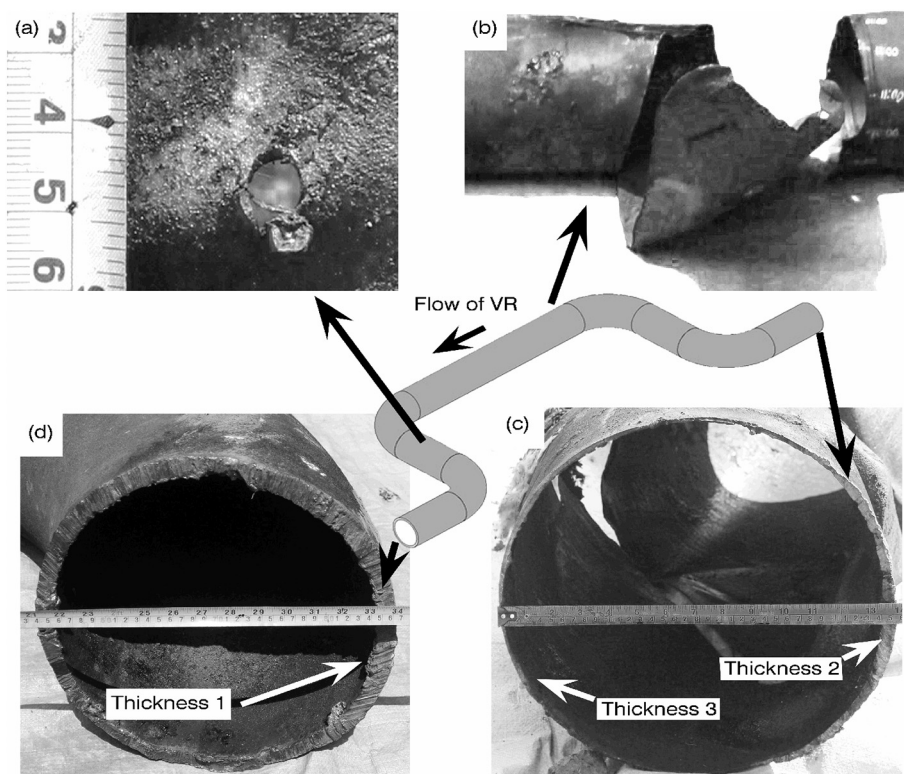
The ASTM A106 grade B [UNS K03006] was chosen because it was the fabrication material of a VR pipe circuit that failed by NAC after approximately 20 years of service in a vacuum residue distillation unit of a crude oil refinery. The pipe was 305 mm nominal diameter, and 19 mm nominal thickness, and it was part of a circuit with origin at the distillation tower and discharge at the vacuum processing unit. The pipe suffered severe uniform and localized corrosion, as shown in Fig. 1. The failure initiated at a corrosion pit of

Fig. 1. Failed pipe of a VR circuit in a vacuum residue distillation unit (a) Open corrosion pit identified as the failure initiation site, (b) Pipe rupture near an elbow, (c) upstream segment, (d) downstream segment.
