Failure analysis of a plate heat exchanger used in a blast chiller

A. Gagliardi^{a,b}, A. Lanzutti^a, M. Simonato^b, R. Furlanetto^b, M. Magnan^a,
F. Andreatta^{a,*}, L. Fedrizzi^a

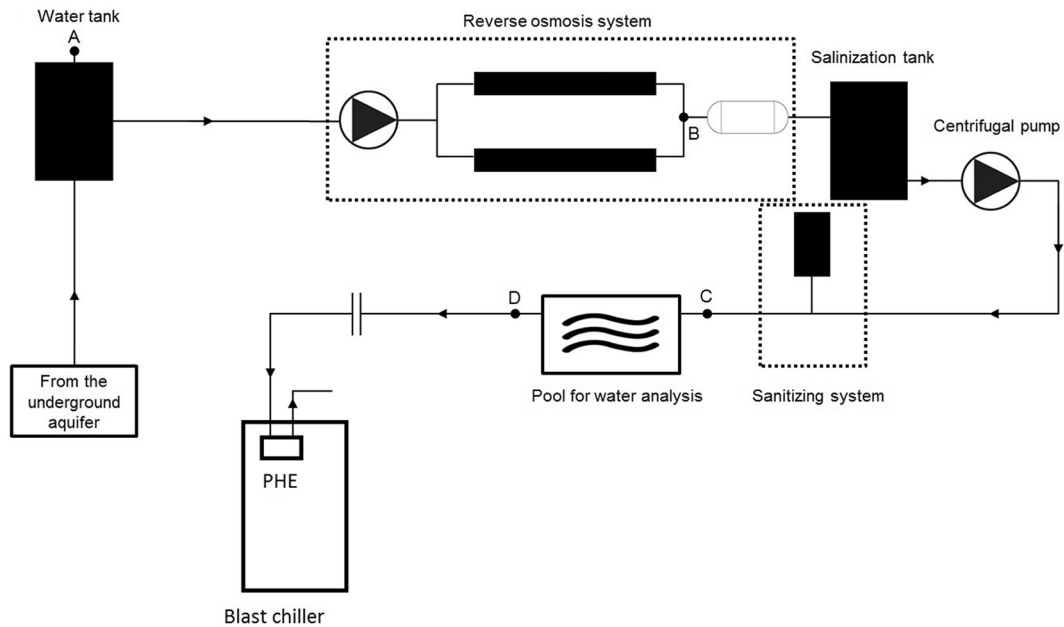
Fig. 1. Scheme of the water treatment plant employing an heat exchanger in the blast chiller. Points where water samples were collected in the plant for composition analysis are indicated in the scheme: A (water tank), B (outlet of the reverse osmosis system), C (outlet of the sanitizing system) and D (inlet of the blast chiller).
