Failure analysis of cold worked AISI 301 SS diaphragm of gas pump

C.R. Das^{*,1}, C. Ravishankar¹, S.K. Albert¹, S.A. Krishnan, A. Moitra¹, K.V. Rajkumar, A.K. Bhaduri¹

Metallurgy and Materials Group, Indira Gandhi Centre for Atomic Research, Kalpakkam 603 102, India

ABSTRACT

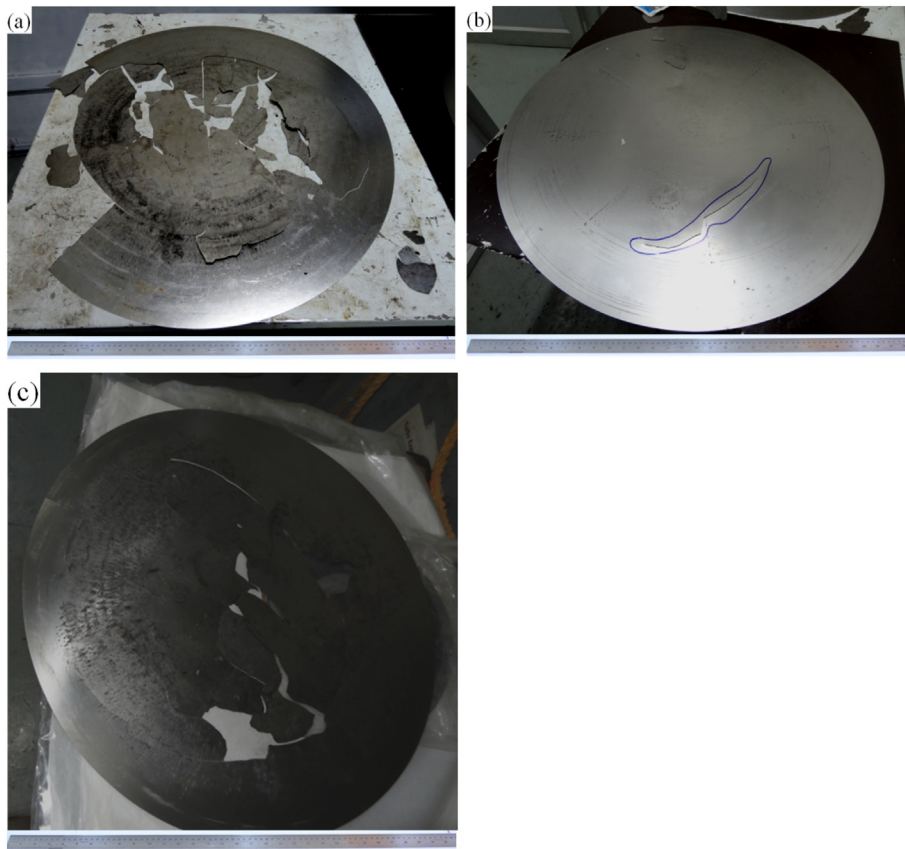
Fig. 1. Diaphragm from (a) oil side, (b) middle and (c) gas side; Metallographic specimens were extracted from the oil side diaphragm, with a 300 mm long sheet being cut from this diaphragm.

Photographs of failed diaphragm are shown in Fig. 1a–c. Visual examination of failed diaphragm reveals that diaphragm failed extensively in the oil and gas side as compared to the middle region. From the figures, it is evident that middle diaphragm had one crack which is bounded by pen mark. On the oil side diaphragm, the rupture appeared to have initiated in the circumferential direction (Fig. 1a). The periphery of all the diaphragms was found to be free of cracks.

Fragments of the diaphragms had discontinuous black and brown marks on the surfaces on which grease was applied prior to operation, Fig. 1b. A few secondary cracks were also found close to the fracture locations. The thickness of the fragments was found to be uniform ~ 0.5 mm, even at locations close to fracture the thickness was found to remain unaltered. Dye Penetrant (DP) inspection carried out on unfragmented portion of the failed diaphragms did not reveal any surface cracks.
