# Failure analysis of worn valve train components of a four-cylinder diesel engine

C. Soffritti\*, M. Merlin, R. Vazquez, A. Fortini, G.L. Garagnani

Department of Engineering, University of Ferrara, Via Saragat 1, I-44122 Ferrara, Italy

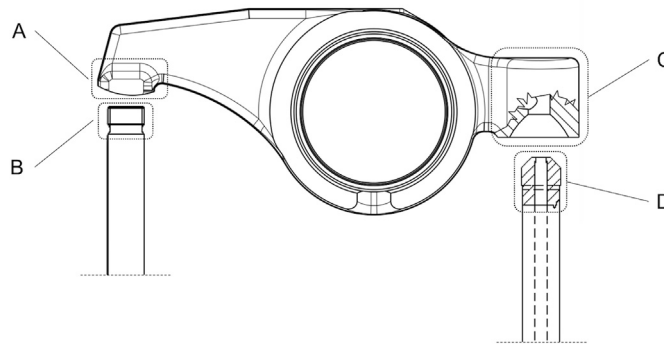
**Fig. 1.** Schematic representation of outlet/inlet rocker arm and parts of pushrod and exhaust/intake valve. The dashed lines enclose the regions with worn surfaces. A: outlet/inlet rocker arm pad. B: exhaust/intake valve stem tip. C: outlet/inlet rocker arm pivot socket. D: pushrod ball end.
