## Experimental and numerical study on the longitudinal-crack failure of double-shoulder tool joint

### ABSTRACT

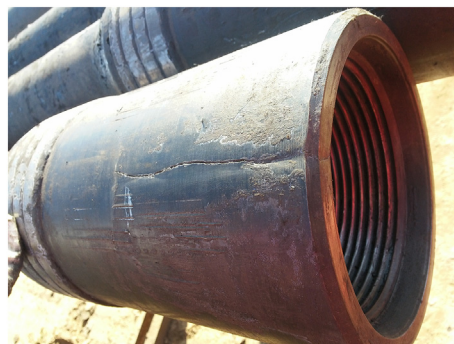
According to the well information, six accidents of 7" S135 tool joint with longitudinal crack occurred in kick-off section of directional wells in the west of China. In this paper, the investigated box tool joint with longitudinal crack is taken from one directional well, whose planned total depth is 5300 m, and longitudinal depth is < 4000 m, and depth of kickoff point is 3000 m. The drilling fluid is brine mud. The bottom hole assembly in this well consists of 12 1/4" BT, screw, HWDP 5 1/2" and 5 1/2" drill pipe. The sticking accident happened at the depth of 3700 m (where the bit had not reached the horizontal section), and then the drill operation was stopped and the drill pipes were taken out from the well by jarring releasing. The obvious longitudinal crack on one box tool joint near sticking point was found, as shown in Fig. 1.

Fig. 1. Outward appearance of the failure joint of drill pipe in the field.
