Investigation of a vehicle fire caused by manufacturing defect

Bin Zhang^{a,b,*}, Zhibao Lu^{a,b}, Zhengang Liu^{a,b}, Guofu Liang^{a,b}, Yingchun Chen^{a,b}

^a Tianjin Fire Research Institute of Ministry of Public Security, Tianjin 300381, China

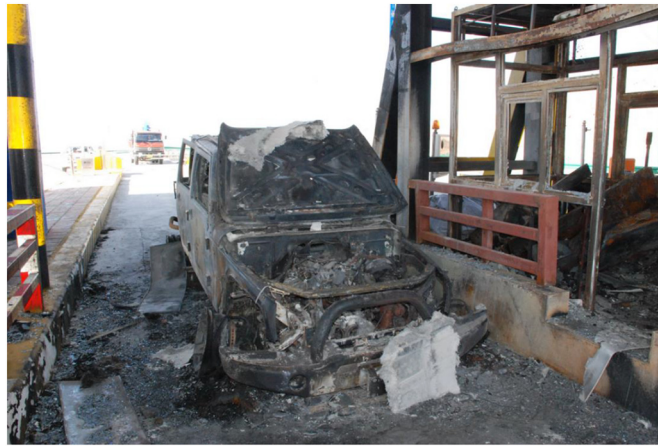
A Sport Utility Vehicle caught fire at idle speed at a toll gate after a 60 Kilometers driving on a highway in Inner Mongolia, P. R. China. The fire destroyed the vehicle and the toll gate and resulted in \$0.5 million in direct property loss as shown in Fig. 1. The witnesses declared that the fire was firstly found around right front tire. The first picture taken by witness after the fire shown in Fig. 2 confirmed the statement. A careful fire scene inspection has been conducted and the area around the right three-way catalytic converter as shown in Fig. 3, was determined to be the area of origin, which coincide with declarations of witnesses.

Fig. 1. A survey of the fire.

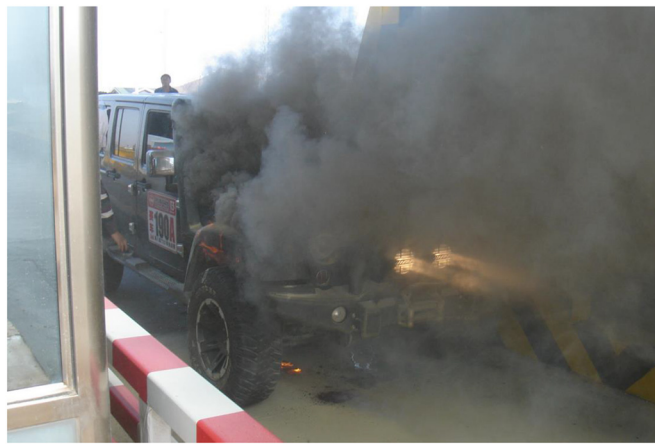
Brake heating was also excluded. Firstly, when the fire was observed and the picture shown in Fig. 2 was taken, the right front size was not ignited. Secondly, the tire was not the in the area of origin.

Fig. 2. First picture taken after the fire indicating the fire origin.

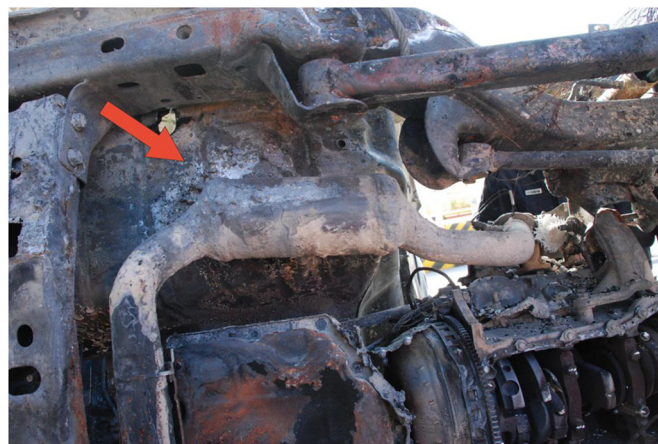
Fig. 3. Area of origin of fire exhibits significantly more damage and color change compared with the others.

During the fire scene inspection, a fracture as shown in Fig. 4, was found on exhaust manifold adjacent to welding joint in the area. The size of the crack is 6.5 cm long and 0.28 cm wide. It was possible that the hot air ejected from right catalytic converter via the fracture ignite the pipeline and/or fuel nearby, initiate the vehicle fire. The possibility was discussed throughout the rest of this article.
