Engineering Failure Analysis

Fatigue failure of the bolts connecting a Francis turbine with the shaft

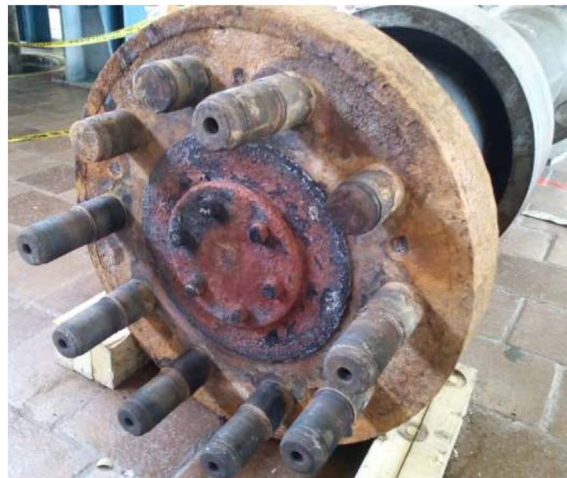
The hydroelectric power unit that is the object of this study has been in operation during the last 50 years. The unit is powered by a Francis-type turbine, which is 1.3-m high and has a major diameter of 2.03 m. The turbine is connected to a 0.46-m diameter shaft using 10 bolt reference DIN 259 R2 ¼", with a material that, according to the manufacturer, has a tensile strength between 784 and 931 MPa. The turbine disassembled approximately once per year for maintenance. By the year 2014, the company decided to replace the old turbine with a new one. To characterize the machine before and after turbine replacement, the company decided to measure the normal and shear stresses on the turbine shaft at several power generation levels. During disassembly of the old turbine, three of the 10 bolts used to connect the turbine to the shaft were found to have broken. The three broken bolts exhibited a fatigue propagation region and a final fracture region. Fig. 2 shows the shaft with the bolts including the three bolts that fractured. Fig. 3 shows the fracture surface of a bolt where the fatigue propagation region is clearly observed. The three bolts were found to have broken at the threaded region in the first fillet in contact with the nut, as observed in Fig. 3.

Fig. 2. Turbine shaft with the bolts after turbine removal.

Better preload control during the assembly process and a change in the bolt material to stainless steel are the primary recommendations from this analysis.
