Engineering Failure Analysis

Failure assessment of a weld-cracked mining excavator boom

The boom section of a hydraulic excavator (23 m³ capacity) suffered a catastrophic failure after nearly 40,000 h of operation at a coal mine comprising more than three-quarters of the cross-sectional area of the boom. Failure analysis is carried out to diagnose the cause(s) and mitigate potential similar failures in coal mine excavator fleet. The analysis methodology involves collection of background data, on-site visual examination, non-destructive testing, macroscopic and microscopic fractography, chemical analysis, metallographic analysis, hardness measurements as well as finite element structural analysis. A crack developed and grew up stealthily at a field weld joint between a man-hole plate and the boom plate. The collected evidence suggests a series of triggering factors leading to the unexpected failure: unmatched plate materials regarding mechanical properties, low-quality weld beads and the introduction of geometric discontinuities that effectively work as stress raisers.

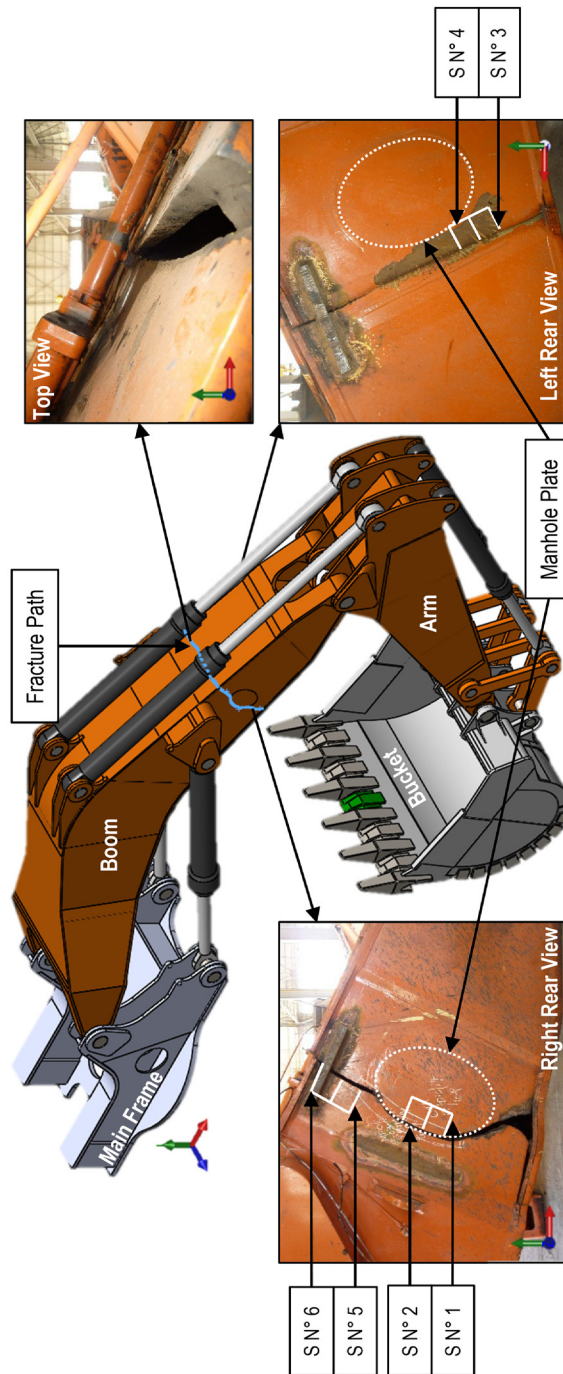
The boom section of a coal mine hydraulic excavator suffered a catastrophic failure during normal operation as a consequence of a crack developed at a field weld joint between a man-hole plate and the boom plate (refer to Fig. 1). The aim of the study relies on diagnosing the cause(s) and mitigating potential similar failures in excavator fleet.

Fig. 1. On-site boom fracture visual inspection and sample selection locations.
