Stress corrosion cracking of a copper elbow fitting

This paper presents the results of an examination of cracking in a phosphorous deoxidised copper fitting that had been installed in a liquid nitrogen line. The service life of the fitting was reported to be three to four years.

Failure was a result of the Stress Corrosion Cracking (SCC) from the outside surface that had been placed in tension by the pipeline being chocked with a block of wood to locally raise the line above a cable tray. The active species for SCC was suspected of being Amines in the Polyurethane insulation.

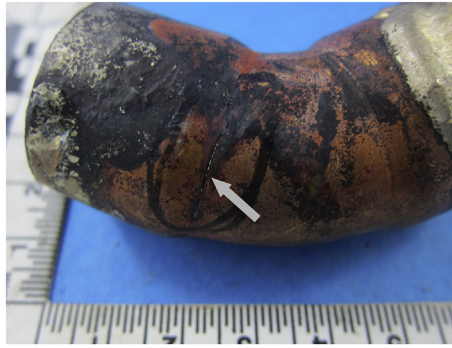
A general view of the fitting is presented in Fig. 1. A circumferential crack approximately 25 mm long was present at the bottom surface of the downstream end, see Figs. 1 and 2. Evidence of a black oxide was present on the surface. The upstream end of the fitting was crack free.

Fig. 1. General view of cracked fitting.

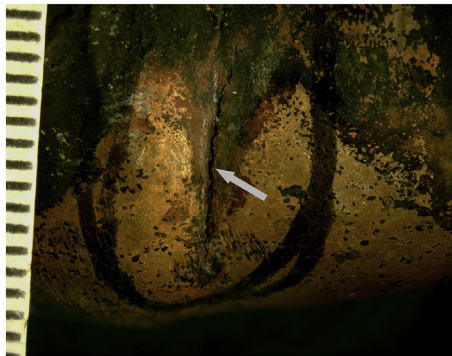
Fig. 2. Magnified view of crack in the external surface of the fitting.

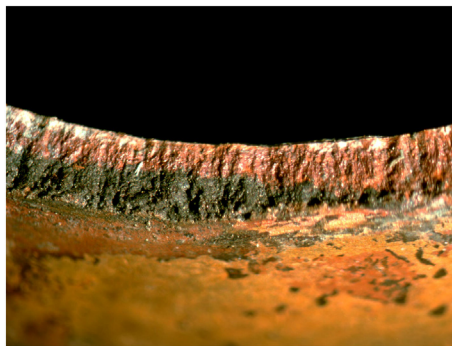
The crack face exhibited a dark, discoloured region at the outer surface extending to a depth of approximately 0.9 mm before exhibiting a bright copper coloured surface, see Fig. 3.

Fig. 3. Magnified view of crack surface.
