Failure analysis of coal bottom ash slurry pipeline in thermal power plant

This paper presents the case study of failure analysis of coal ash slurry handling pipeline used in the thermal power plant. The failure was identified at the bottom portion of the pipeline. Cracks (Hole) and deep pits were observed at the bottom inner surface of the pipeline. Visual examination, dimensional analysis, SEM and EDS analysis of failure pipeline was done in the present failure case. Also, coal bottom ash was analysed using particle size and weight analysis, ultimate, proximate, SEM, EDS and solid concentration analysis for the present failure case. The analysis results have shown that the failure occurs due to the coal ash solid particle impact and deposited corrosion at the inner bottom surface of the pipeline i.e. solid particle slurry erosion wear. The slurry pipeline was made of mild steel.

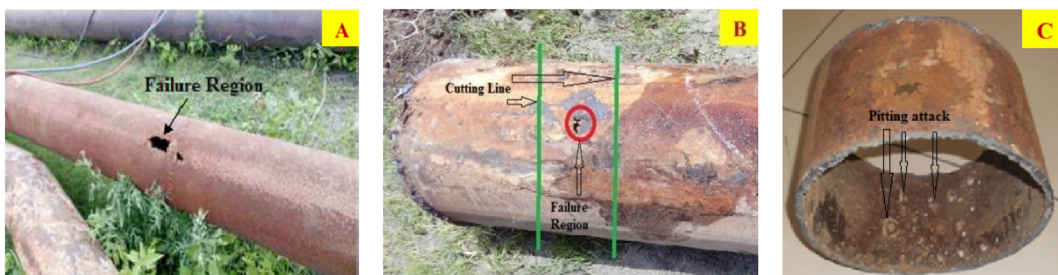
Fig. 1 (A and B) shows the location of leakages on the coal ash slurry pipeline in two different areas. Fig. 1B shows the cut portion of same failure pipeline considered for the present investigation. The pipeline which had failed was inspected and a large crack (hole) was observed. A small portion of the pipeline with failure region crack (hole) (Fig. 1(B)) was cut along the two cutting lines and observed with naked eyes. The external and internal surface had oxide scale over it branching at the subsurface. In addition to that several localized pitting and ploughing attacks were observed in inner top and bottom surface of the pipeline respectively as shown in Fig. 1C. This is because of large size and mass of coal ash particles which comes in contact with the bottom inner surface of the pipeline when coal slurry is flowing through the pipeline. Similarly, the top inner surface mostly comes in contact with air bubbles which have occurred due to variation in particle size, shape and temperature of ash particle flowing through the pipe.

Fig. 1. Actual failure section of the coal ash slurry pipe with exact location of leakages.
