Engineering Failure Analysis

Analysis of intergranular stress corrosion crack paths in gas pipeline steels; straight or inclined?

Olivier Lavigne^{a,*}, Erwin Gamboa^{a,b}, Vladimir Luzin^c, Michael Law^c^a School of Mechanical Engineering, The University of Adelaide, South Australia 5005, Australia^b TransCanada, 450 1st St SW, Calgary, Alberta T2P-5H1, Canada^c Australian Nuclear Science and Technology Organisation, Lucas Heights, NSW 2234, Australia

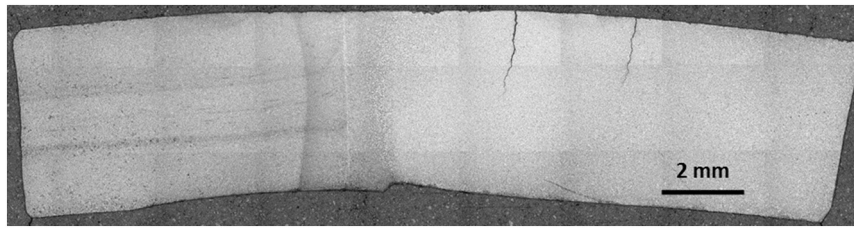
Fig. 1. X42 pipe transverse view showing weld and typical straight stress corrosion cracks.

The samples were cut out of pipe sections made of API 5L X42 steel (Fe bal., C 0.23 wt%, Mn 0.64 wt%, Si 0.01 wt%, S 0.03 wt%, P 0.01 wt%, Ni 0.01 wt%, Cr 0.01 wt%) extracted from the field after 39 years of operation and showing stress corrosion cracking (Fig. 1). The nominal wall thickness and the external diameter of the pipe were respectively 4.37 and 168.3 mm. The pipe was manufactured from centre slit strip and via the electric resistance welding (ERW) process and coated with an adhesive PVC tape wrap on the top of a rubber type layer. The pipe sections were extracted at approximately 40 km downstream from a compressor station, where the soil temperature was estimated to be between 15 °C and 25 °C through the year. The maximum allowed operating pressure (MAOP) of the line was 8.24 MPa.
