# Engineering Failure Analysis

## A failure analysis of the exhaust valve from a heavy duty natural gas engine

Muhammad Imran Khan<sup>a,\*</sup>, Muhammad Arsalan Khan<sup>b</sup>, Abdul Shakoor<sup>b</sup>

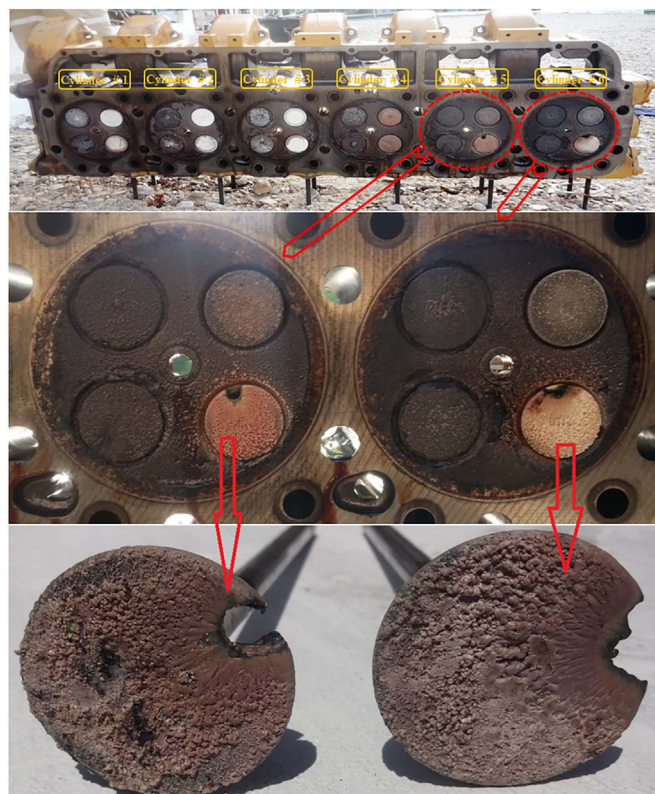
Fig. 1. Showing Cylinder head from a Caterpillar G3406 natural gas engine with guttered exhaust valves and showing high deposits after 10,000 h.
