Embrittlement of welded joints of tram rails in city environments

ABSTRACT

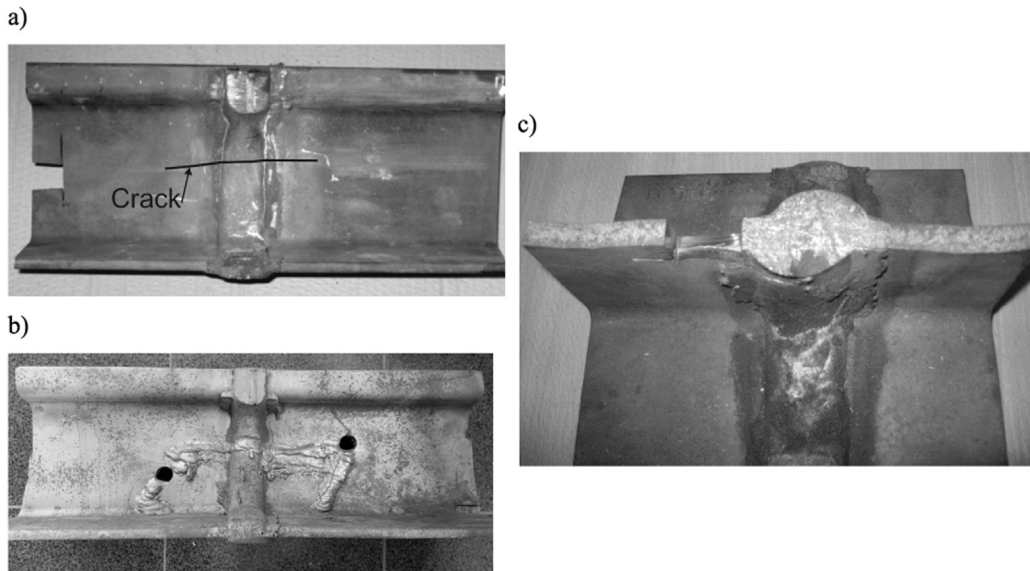
Fig. 1. Sections of grooved tram rails: a) cracked right after thermite welding, b) cracked in the course of operation, c) bottom surface of the rail crack (Fig. 1a).
