Failure analysis of branch connection on the reactor primary pipeline

ABSTRACT

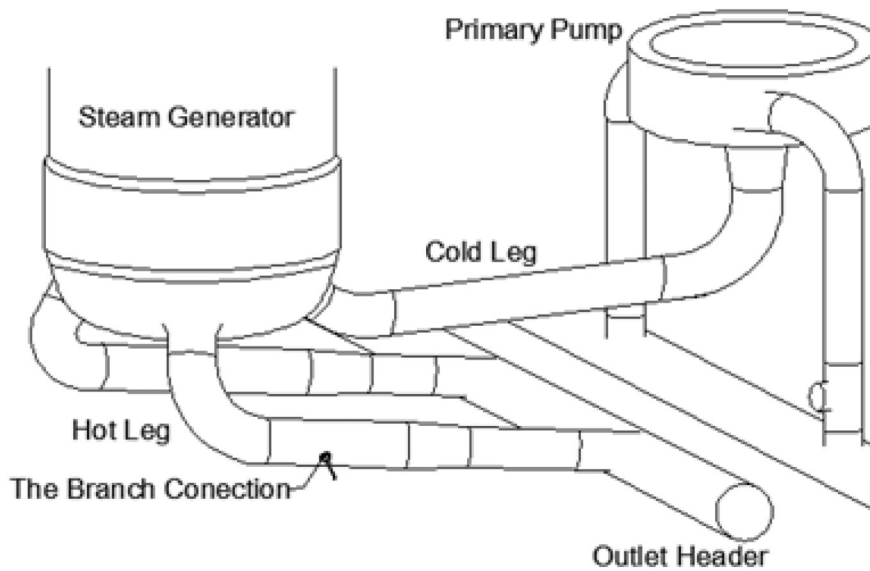
Fig. 1. The location of the branch connection.

The leakage point was finally identified on a branch connection of the reactor primary loop, as shown in Fig. 1. It located on a primary pipe, which is a hot leg of a steam generator. Table 1 shows the basic information of the connection. Fig. 2 shows the connect structure of the branch connection. The leakage was on the stainless steel side of the dissimilar weld. The metallurgical samples were
