Investigation of failure of steel steam generating evaporator tube involving delamination defects and corrosion

D. Luder*, B. Erenburg, E. Iskevitch, S. Ariely, M. Yalin

Materials Lab, Israel Electric Corporation, Nativ Haor 1, Haifa 31000, Israel

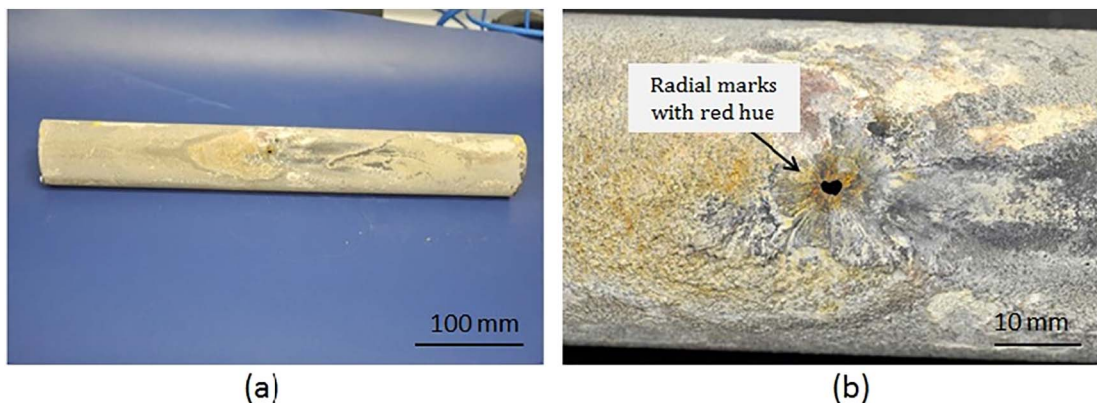
An image of the tube as received from the power station including a close view of the hole is presented in Fig. 1.

Visual examination revealed combustion and ash deposits typical of coal fired boilers on the tube's outer surface. Around the hole it is possible to observe radial marks caused by the steam burst, it is suggested the deep red hue around the edge of the hole constitutes evidence of hot corrosion (Figs. 1–2). The tube was sectioned and the ribbed inner surface near the hole was revealed, as presented in Fig. 2. It is observable that a whole layer of metal had detached from the surface at the area where the hole had formed, a sketch of the cross section is presented in Fig. 3 (working parameters supplied by power station staff). By observing that the hole exists on the tube wall but is absent from the detached layer, it is discernible that the detachment had occurred prior to the hole formation. The substantial wall thinning due to the detachment created a situation where the remaining wall thickness could not withstand the working pressure and temperature, leading to accelerated wall thinning until it breached. Yellowish deposits can be observed near and around the peeled area. The yellow deposit layer's abrupt cut-off at the surface left over from the detachment shows that the layer existed on the surface before the detachment event (Fig. 2). Evidence of hot corrosion in the form of a deep red hue can be seen near the hole on the internal surface of the tube (Fig. 2), as also seen from the external surface in Fig. 1. Due to the limited radius of the red corroded surface, it is strongly suggested that this corrosion, and possibly simultaneous erosion, occurred near the time of breach, and that at the same time, the hole area experienced temperatures much higher than the rest of the tube. It is suggested that these high temperatures were both due to friction of gas flow and very high heat transfer from the exterior prior to and during the burst, when wall thickness became very thin (in the immediate vicinity of the hole). This is evident by the absence of deep-red corrosion products beyond 2–3 mm from the hole, apart for limited superficial corrosion common in evaporator tubes. The wall thickness at the hole is ~300 µm compared to 6 mm, and the outer surface has remained intact apart for the hole itself.

Fig. 1. (a) Showing the tube as received from the field (b) a close view of the hole.
