## Corrosion investigation of stainless steel water pump components

A. Vazdirvanidis, G. Pantazopoulos\*, A. Rikos

ELKEME Hellenic Research Centre for Metals S.A., 56th km Athens-Lamia Highway, 32011 Oinofyta-Viotia, Greece

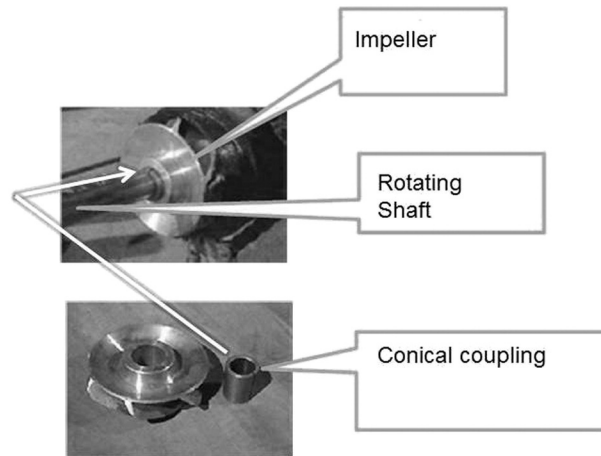
Two components of a water pump installed in a casting shop for recirculation of cooling water experienced severe and accelerated corrosion after two months in service. The received components of the water pump assembly constituted a shaft and a conical tube, which worked as a connector with the impeller (Fig. 1). The shaft exhibited severe pitting corrosion in specific areas in connect with another pump component (Fig. 2).

Fig. 1. Images illustrating the components' assembly of the pump.

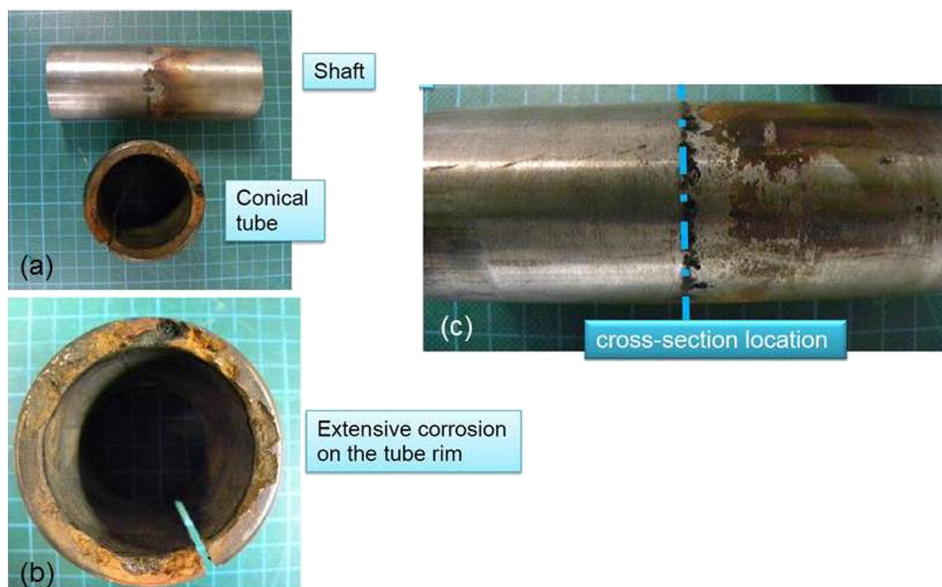
Fig. 2. Macrographs showing the corroded coupling and shaft parts of the pump.
