Engineering Failure Analysis

Failure analysis of massively failed compressed air cartridge

L. Klakurková, M. Horynová*, M. Juliš, P. Gejdoš, P. Skalka, M. Remešová, L. Čelko

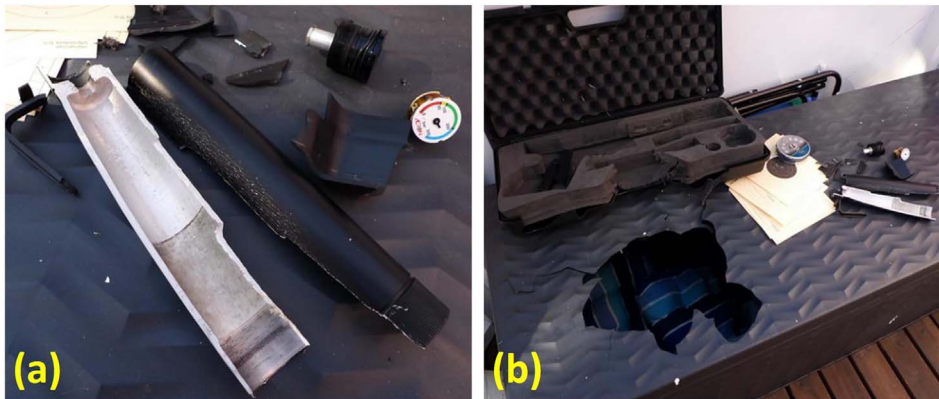
This study deals with not optimal change of material and technology for air cartridges production, which, together with improper manipulation, resulted in a failure and following explosion of air cartridge. Appearance of the cartridge that was left in the case at direct sunlight on the premises of shooting range and exploded is shown in Fig. 1. As can be seen, not only cartridge, but also gun case and shelf that case was placed on were damaged. Besides, roof of the object that gun case was placed in was also damaged.

Fig. 1. (a) Appearance of exploded cartridge, (b) appearance of gun case and shelf, on which the case was placed.
