# Engineering Failure Analysis

## Failure analysis of casing of draft tube of turbine used in hydropower plant

M. Horynová\*, L. Klakurková, J. Švejcár, M. Juliš, P. Gejdoš, L. Čelko

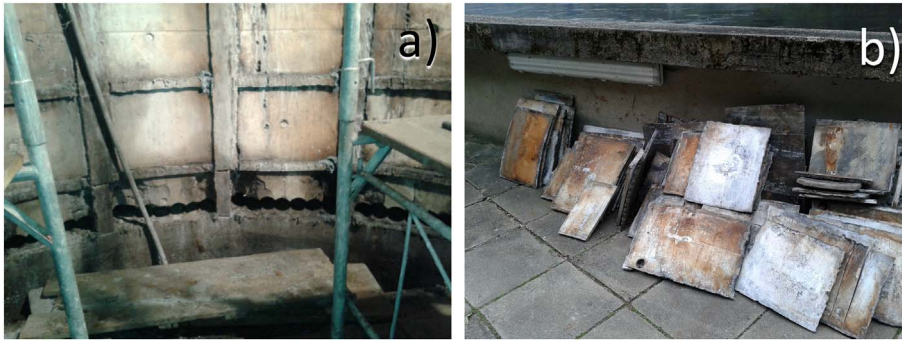
Fig. 1. (a) replacement of draft tube, (b) individual sheets after removing from the draft tube.

Failed draft tube from hydropower plant turbine was replaced (see Fig. 1) and part with visible cracks and degraded area was submitted to as by a customer for further analysis. It was specified by the detail drawing documentation that submitted part is a weldment—two welded sheets with the thickness of 20 mm. Both sheets were supposed to be made of the same material, 17 246 stainless steel (ČSN 41 7246 Standard), equivalent to X6CrNiTi18-10 stainless steel.

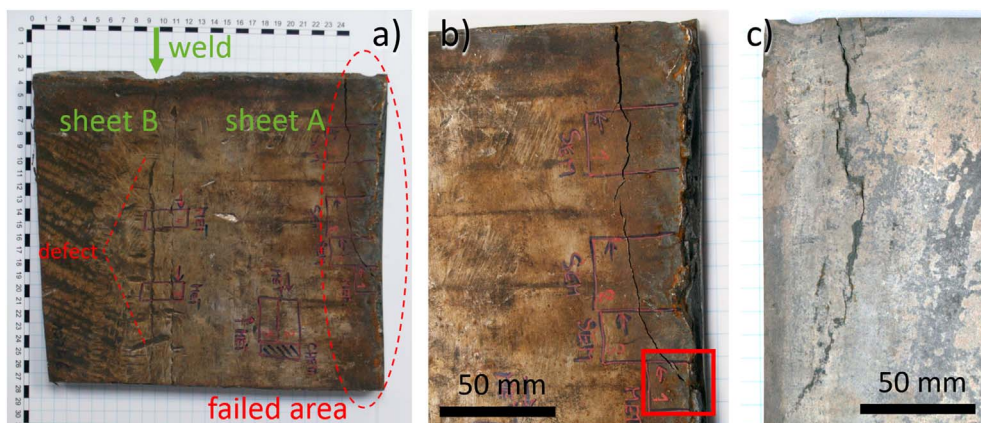
Draft tube was replaced and failed material send to our laboratory for further analysis in order to confirm cause of the failure and analyze degradation mechanism. Comprehensive analysis of chemical composition and microstructure of material used for the draft tube was revealed, that component failed due to intercrystalline corrosion resulting from unsuitable chemical composition and

Submitted part is shown in Fig. 2. At first a detailed visual inspection was performed in order to determine degraded areas and other areas of interest. As can be seen from Fig. 2, sheet A contained distinctive crack. Another defect was observed along the weld on the side of sheet B. Samples for further observation were taken from both mentioned areas i.e. one sample from the degraded area of the sheet A and one sample for cross-section macro-observation of the weld.

Fig. 2. Part of the draft tube submitted for analyses: (a) overall image, (b) detailed image of the crack—inner side with designated sample for analysis, (c) detailed image of the crack—outer side.
