# Failure of mounting bolt of helicopter main gearbox support strut

Branimir Krstic<sup>a,\*</sup>, Lamine Rebhi<sup>a</sup>, Nada Ilic<sup>b</sup>, Marjan Dodic<sup>a</sup>, Mirko Dinulovic<sup>c</sup>, Predrag Andric<sup>d</sup>, Dragan Trifkovic<sup>a</sup>

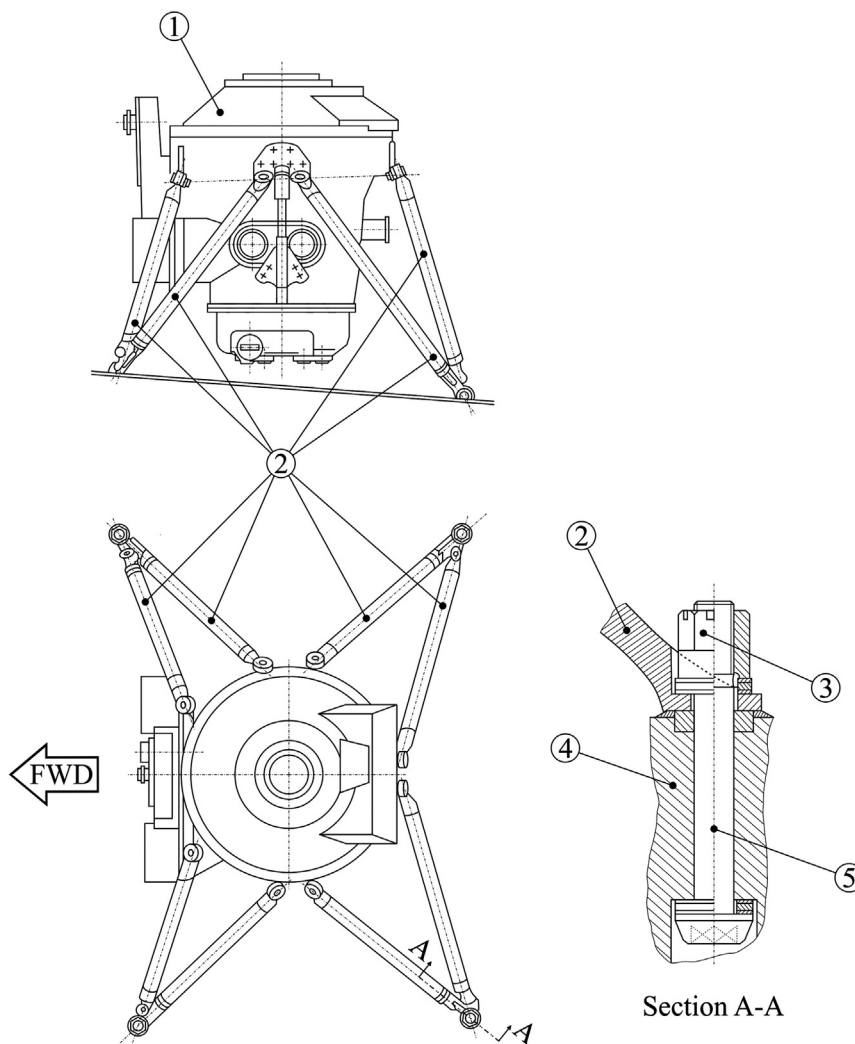
This study presents a metallurgical and numerical failure analysis of mounting bolt of the main gearbox support strut of the military helicopter Mi-8. The failure occurred in 2013 during the flight mission and the postflight inspection revealed that the mounting bolt of the aft left support strut of the main gearbox was fractured. The considered bolt was original equipment on the 33-year-old helicopter. By the time of the occurrence flight, helicopter had accumulated 3090 flight hours since new and 1097 h since overhaul.

Fig. 2. Schematic drawing of the main gearbox support assembly and longitudinal section through the bolt of the aft left support strut: 1 - helicopter main rotor gearbox; 2 - support strut; 3 - castle nut; 4 - reinforced airframe no.10; 5 - bolt.
