In-situ NDT testing procedure as an integral part of failure analysis of historical masonry arch bridges

Otello Bergamo^{a,*}, Giuseppe Campione^b, Stefano Donadello^a, Gaetano Russo^a

A nineteenth-century masonry arch bridge was analyzed as an illustrative example to explain the role of in-situ test campaigns in failure analysis and retrofit design. Test results were studied to find out the advantages of each technique, with the aim of proposing an optimized in-situ testing procedure. Standard static penetrometer, flat jack, thermographic and georadar in-situ tests were conducted. Traffic effects were analyzed by means of vibrational tests. The experimental analysis performed to investigate damage on the bridge structures shows the degree of reliability offered by each technique in evaluating specific information and reproducing the global behavior of the structure.

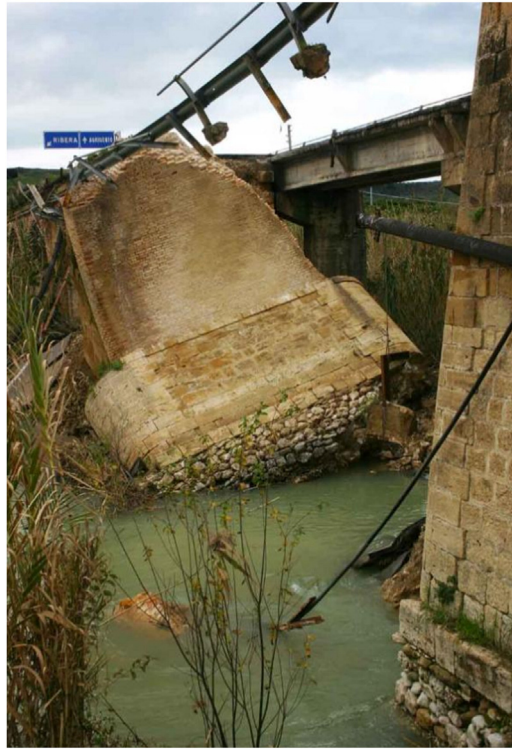
Fig. 1. The collapse of “Ponte Verdura” in Sciacca (Sicily).

The recent collapse in Sciacca (Sicily – Italy) on 4th February 2013 of the masonry arch bridge “Ponte Verdura”, dating from 1870, is shown in Fig. 1. The collapse as “rigid body” of the pier is principally due to geotechnical and hydraulics causes.
