Analyses of a leaking styrene-acrylonitrile water-filter housing

Borut Zorc^{a,b,*}, Aleš Nagode^b

^a Welding Institute Ltd, Ptujška 19, Ljubljana, Slovenia

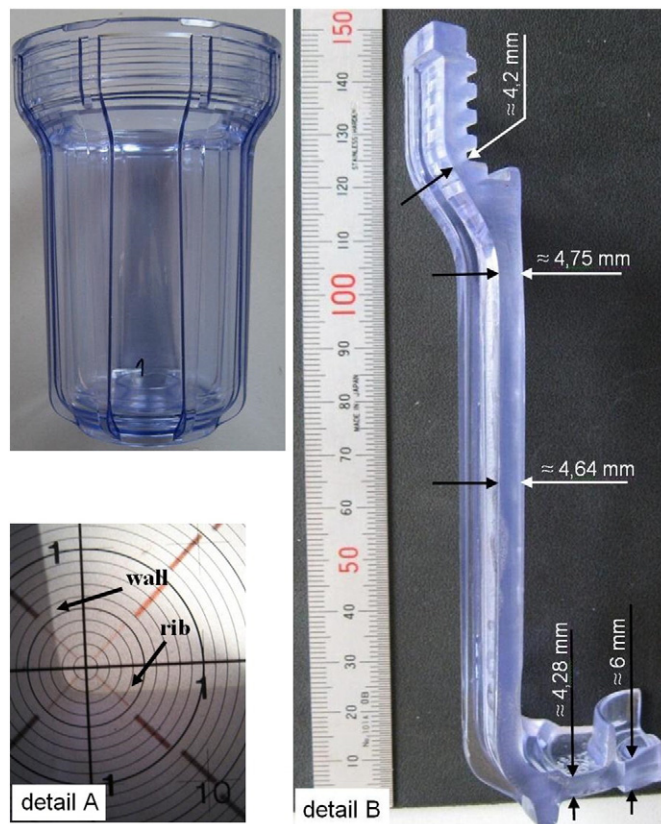
In order to find the source of the leaks, the company delivered eight water-filter housings for the investigation. The water-filter housing has a cylindrical shape with eight vertical external ribs (Fig. 1). The colour of the housing is a transparent blue. The internal surface of the upper part of the filter housing is threaded, which allows the housing to be screwed to the filter head. The radius of the transition between the ribs and the wall of the filter housing is $r = 0.2$ mm (Fig. 1, detail A). The thickness of the walls varies with the height (Fig. 1, detail B).

Fig. 1. The shape (a) and some dimensional characteristics (b, c) of the water-filter housing.
