Failure of two overhead crane shafts

Ž. Domazet, F. Lukša*, M. Bugarin

University of Split, Faculty of Electrical Engineering, Mechanical Engineering and Naval Architecture, Ruđera Boškovića 32, 21000 Split, Croatia

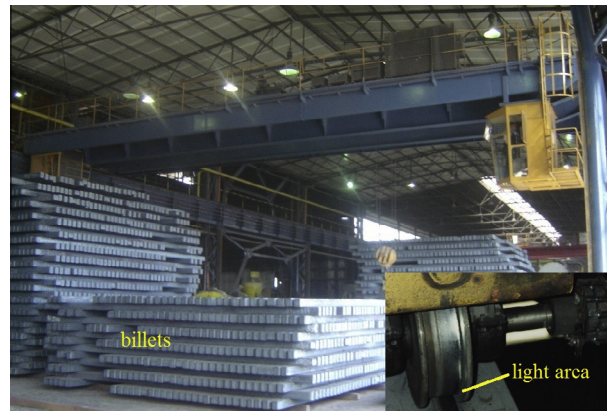
Fig. 1. Overhead crane for transport of billets.

In “Steelworks Split” the high-speed electric overhead crane, Fig. 1, was suitable for transport of the billets from the melt shop to the rolling mill hall. The crane was rated at 10 tons with span 20.5 m and handled about 100 lifts and transports per day, each lift averaging 5 tons. The stepped drive shaft used for an overhead crane trolley wheel fractured after 24 months of service. The electric motor power rating was 3 kW with an output speed of 940 rpm. The maximum travel speed of the trolley was 32 m/min.

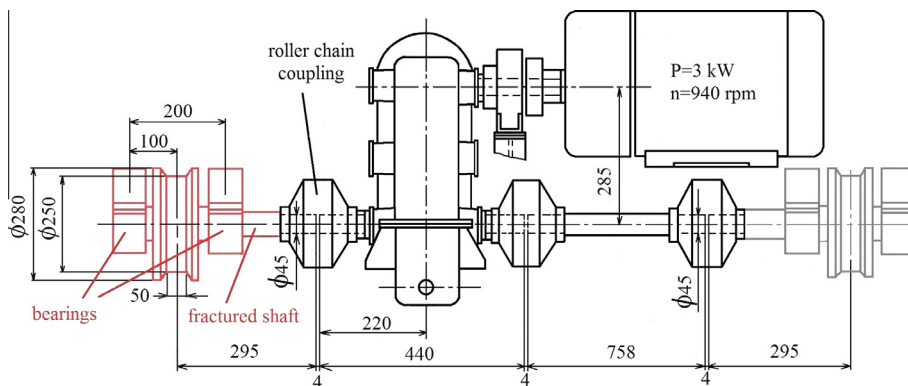
Fig. 2. Overhead crane trolley [2].

The shaft was connected with the gearbox by a roller chain coupling, supported by two roller bearings and connected with the wheel by a key, Fig. 2.
