Failure analysis of a steam pipe weld used in power generation plant

Qiaoling Chu, Min Zhang, Jihong Li, Yinni Chen, Hailong Luo, Qiang Wang

Qiaoling Chu, Min Zhang, Jihong Li, Yinni Chen, Hailong Luo, Qiang Wang  
College of Material Science and Engineering, Xi'an University of Technology, Xi'an, 710048

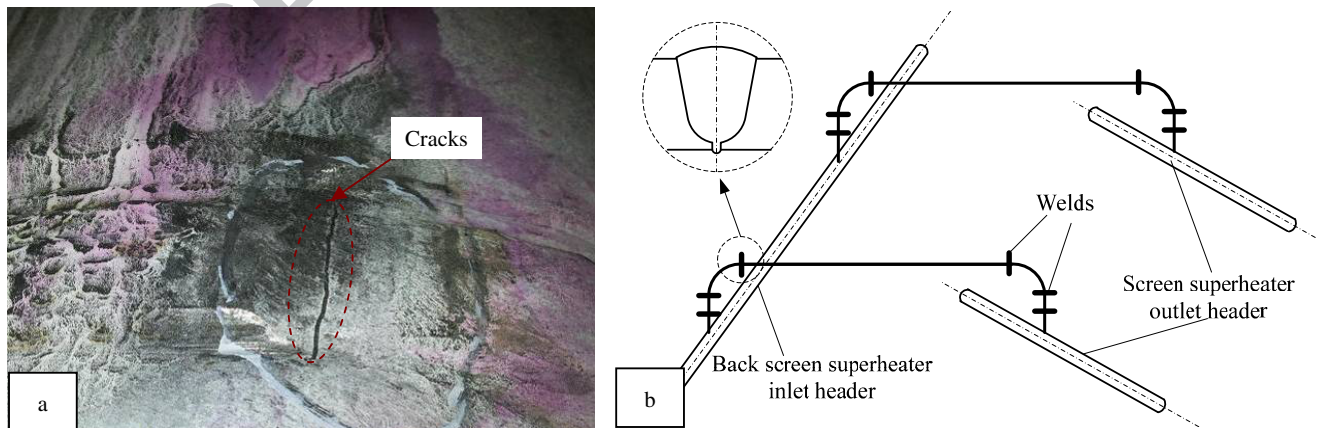
During the maintenance halt of a power generation plant, a steam pipe connected with tee-junction structures was detected transverse cracks in welded joint (Fig. 1a). This failed pipe is manufactured from 1%Cr-0.3%Mo-0.2%V steel. Fig 1b displays the assemble diagram of the investigated steam pipe. The failed pipe is combined by shielded metal arc welding (SMAW) with matching electrodes (ASW E5515). The subsequent post-weld heat treatment(PWHT) ( $700^{\circ}\text{C}\times 5\text{h}$ ) is employed to alleviate the welding residual stresses. According to the record of operation for the steam pipe unit, the failed pipe has operated at around 140000 h. The pipe has an out-diameter of 450mm and a wall thickness of 50mm. The conveying medium is steam with average pressure of 17.4MPa and temperature of  $510^{\circ}\text{C}$ .

Fig. 1 General view of the cracks analyzed. (a) Cracks in welded joint; (b) Assemble diagram of the investigated steam pipe.
