Potential hazards from undetected corrosion in complex equipment: A case study of the destructive separation of an offshore heat exchanger

R. Parrott*

Health and Safety Laboratory, Harpur Hill, Buxton, Derbyshire SK17 9JN, UK

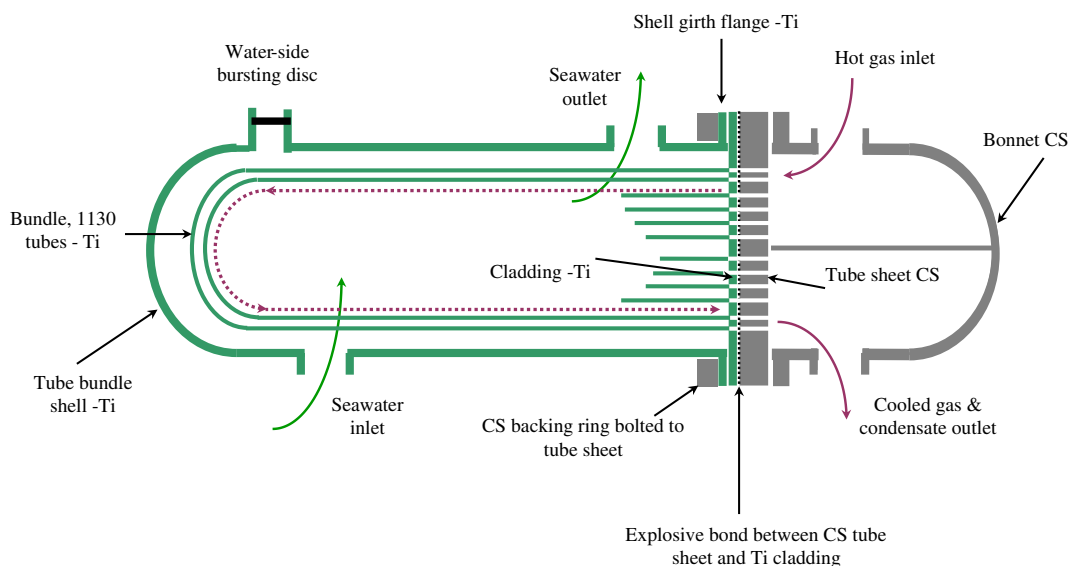
The heat exchanger was a conventional shell-and-tube bundle design that was manufactured in 1983 for a gas pressure of 100 bar (1450 psig) in the tubes and a shell seawater pressure of 10.3 bar (150 psig). At the time of failure, the gas pressure was 90 bar (1300 psig) and the cooling water pressure was 10 bar (145 psig). The heat exchanger was approximately 9 m long overall with a shell diameter of 1 m and a bundle of 1130 tubes, each 6.5 m long. The tube specification was $\frac{3}{4}$ in. OD, 16 BWG tubing to ASTM/ASME SM338 Grade 3 titanium. Fig. 1 shows the main components schematically.

Fig. 1. A diagram showing the key features of the heat exchanger and the seawater and gas flows in normal operation.
