Engineering Failure Analysis

Hot-water corrosion failure of a hard-drawn copper tube

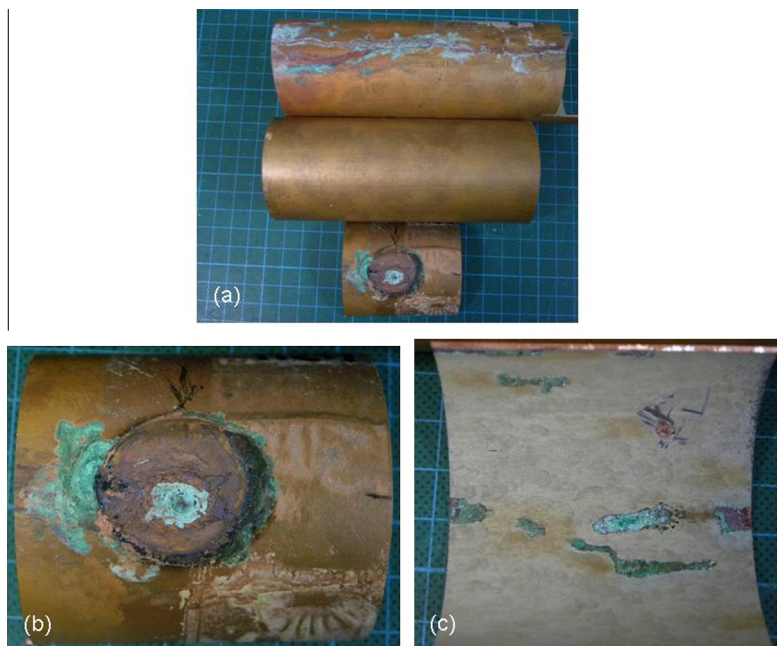
Macrographs showing outer and inner tube surfaces are presented in Fig. 1, suggesting that corrosion processes initiated from inner tube surface. Stereomicroscopic observations indicated accumulation of corrosion deposits (green scale) adjacent to the leakage waterside region (Fig. 2).

Fig. 1. Macrographs showing (a) the as received samples, (b) outer surface of the tube at the leakage area and (c) inner surface of the tube. The presence of corrosion products in the inner tube area is noticeable.
