# Mechanism and risk assessment of overall-instability-induced rockbursts in deep island longwall panels

Sitao Zhu<sup>a</sup>, Yu Feng<sup>b,\*</sup>, Fuxing Jiang<sup>a</sup>, Jinhai Liu<sup>c</sup>

An increasing number of mines in China are being subjected to overall-instability-induced (OII) rockbursts in extracting deep remnant island longwall panels, causing severe damage at far larger scale and intensity compared with common local rockbursts. Using the island longwall panel LW1305 at Zhaolou Coal Mine as a case example, this paper investigates the mechanism of the newly defined OII rockburst by means of stress and microseismic monitoring, and then proposes a straightforward risk assessment method for OII rockbursts based on the actual bearing index in an attempt to provide guidelines for making engineering judgement. The proposed risk assessment method was successfully applied to LW1305, and the assessment result is supported by the occurrence of an OII rockburst in LW1305, and further verified by numerical modeling and microseismic monitoring.

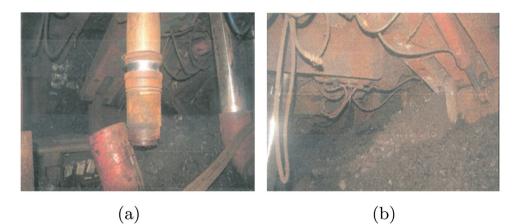
Fig. 2. Photographs of an OII rockburst in LW3112 at Chaoyang Coal Mine showing (a) collapsed supports and (b) blocked gate roads.
