Interlaminar damage of carbon fiber reinforced polymer composite laminate under continuous wave laser irradiation

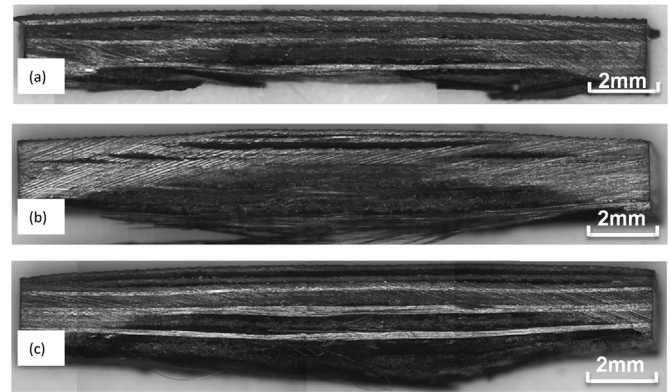
The typical cross section morphologies by optical microscope are shown in Fig. 2. It is revealed that the obvious pyrolysis happened in the irradiated region of the specimens, and the interlaminar cracks could be found close to the backward surface other than the irradiated forward surface.

Fig. 2 also reveals fiber fracturing in the surface layer directly irradiated and the pyrolysis could be observed in up to eight

Fig. 2. Cross section for the cases of laser power (a) 500 W, (b) 800 W and (c) 1000 W.

laminae counted from the forward surface layer. Moreover, it is shown that several layers of carbon fiber remained even after the matrix removed by the laser irradiation. To reveal further characteristics of the interface damages in the specimen, the cross section morphology observed by scanning electron microscope are shown in Fig. 3 and 4. The interface cracks, indicated by black lines and the pyrolysis front edge, indicated by red lines are further sketched in Fig. 5 to reveal clearly their locations and geometrical characteristics. The distinctive line widths are intentionally chosen in the sketch to approximately represent the opening displacement of the interlaminar cracks. The crack of maximum opening displacement, which always appears at the center of the penny-shaped cracks, than the half thickness of a single lamina is simply named as coarse crack in the manuscript, otherwise as fine crack. According to the experimental observation, the location of the most coarse crack and the pyrolysis front edge would move to the backward surface were the laser power increased, which is also sketched in Fig. 5. Of course, the crack opening displacement should be intrinsically related to the thermal strain and thermal stress developed in the specimen. The out-of-plane deformation of the laminate contributes largely to the opening displacement of the interlaminar cracks, which is directly resulted from the asymmetric thermal expansion of the laminates.
