Case study

Analysis of cracks generated in the spinning-mandrel teeth

M. Haghshenas*, R.J. Klassen

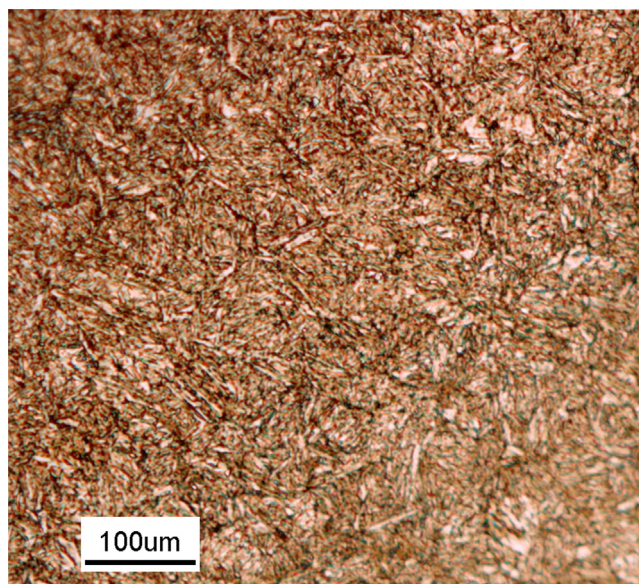
The microstructure of the mandrel contains bainite and martensite (Fig. 2). The bainite constituent contributes to fairly good toughness in this kind of tool steel (Fig. 3).

Fig. 2. The microstructure of the quenched and tempered shock resistance tool steel containing bainite and martensite phases.
