Case Studies in Engineering Failure Analysis

Failure analysis of a bearing in a helicopter turbine engine due to electrical discharge damage

National Transportation Safety Board, 490 L'Enfant Plaza East, SW, Washington, DC 20594, United States

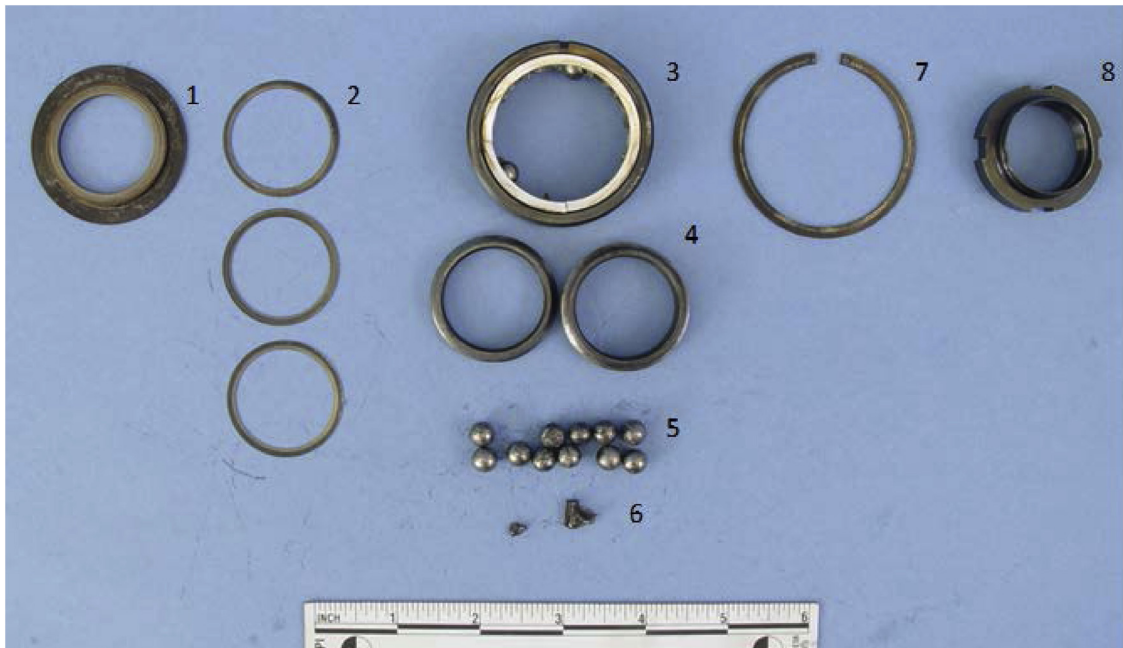
Further disassembly revealed that the No. 2 bearing, P/N 6889093AL, ball retainer was fractured. The ball bearing retainer was separated in two locations and numerous balls within were gouged on their surface and deformed. A thin oil film was present and no noticeable discoloration was observed. The shim and oil slinger were intact. A review of the records revealed that during the overhaul, a new No. 2 bearing was installed: P/N 6889093AL, serial number (S/N) TA 36-0510763.

Fig. 1. Picture of the as-received No. 2 bearing pieces, oil slinger, shims, retaining ring, and spanner nut as identified in the following list: (1) oil slinger, (2) shims, (3) No. 2 bearing piece (outer race, retainer pieces, and two balls), (4) No. 2 bearing inner race halves, (5) eleven bearing balls, (6) bearing retainer pieces, (7) retaining ring, (8) spanner nut.
