## Case study

## Failure analysis of air cooled condenser gearbox

Anand Parey\*, N.K. Jain, S.C. Koria

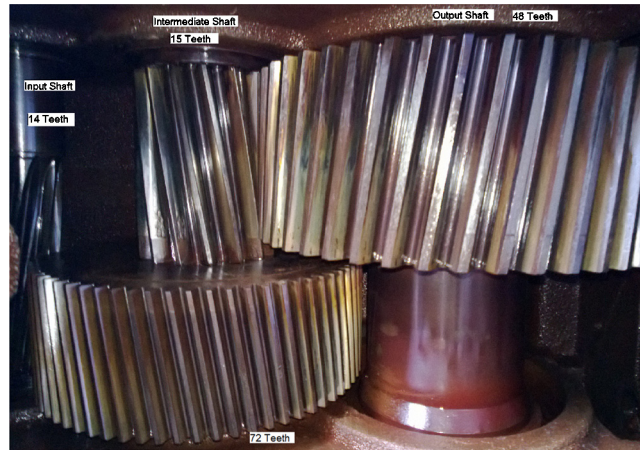
Fig. 1. Arrangement of the gears of the ACC fan gear box.

having 14 teeth meshes with the bigger gear having 72 teeth mounted on the intermediate shaft. The output gear having 48 teeth meshes with the smaller gear (referred as intermediate pinion) having 15 teeth and mounted on the intermediate shaft. The intermediate pinion was observed with severe damage.
