Case Studies in Engineering Failure Analysis

Failure analysis of the impellers of coke plant

Souvik Das*, Goutam Mukhopadhyay, Sandip Bhattacharyya

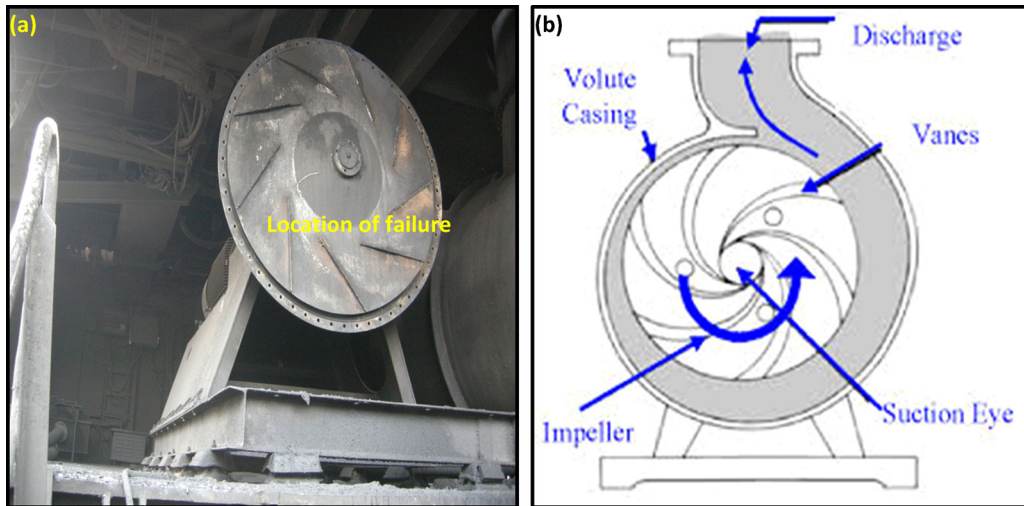
Centrifugal pumps are turbo machines used for transporting air or gas by raising a specified volume of the flow to a specified pressure level. The basic centrifugal pump components are: the casing, the bearing housing, the pump shaft and the impeller. As the impeller rotates, the gas is accelerated by the rotating element within the confined space created by the volume of the compressor's casing. The gas is compressed as more gas is forced into the volute by the impeller blades. The pressure of the gas increases as it is pushed through the reduced free space within the volute. In these studies premature failure investigation of impeller blade was carried out. The component functioned during the CGC gas intake cycle. The component rotates at 1480 rpm with a volumetric flow of 720 m³/min of flue gas with temperature about 200–300 °C. The expected life of the component is 5 years while the component failed within 3 years of its service (Fig. 1).

Fig. 1. (a) The assembly site of the failed impeller; (b) schematic drawing of the impeller.

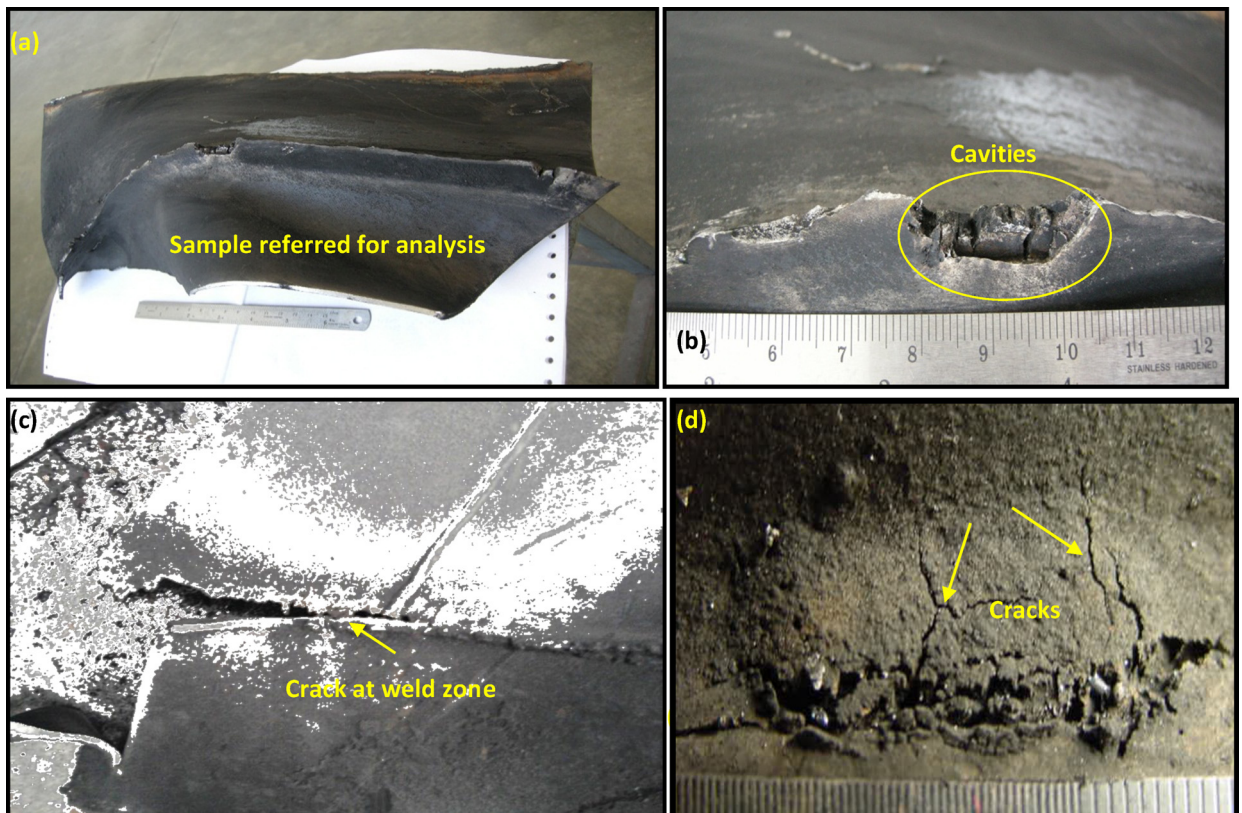
Plant Visit was conducted to understand the problem. During plant visit it has been observed that after premature failure of the component several areas were detected on the blades and at the attachment zone of the blades and the hub where weld-repair work on the cast was performed. A triangular piece of the first centrifugal blower impeller blade was submitted for metallurgical analysis of the cause of cracking. The piece had been extracted from the rest of the blade, as referenced Fig. 2a. It contained an exposed surface of a crack that extended slightly beyond the assembly weld from the leading edge

Fig. 2. (a) Full view of sample referred for analysis; (b–d) cracks at various location of the component.
