Analysis of the failure of an offshore compressor crankshaft

William Harris*, Keith Birkitt

Health and Safety Laboratory, Harpur Hill, Buxton SK17 9JN, United Kingdom

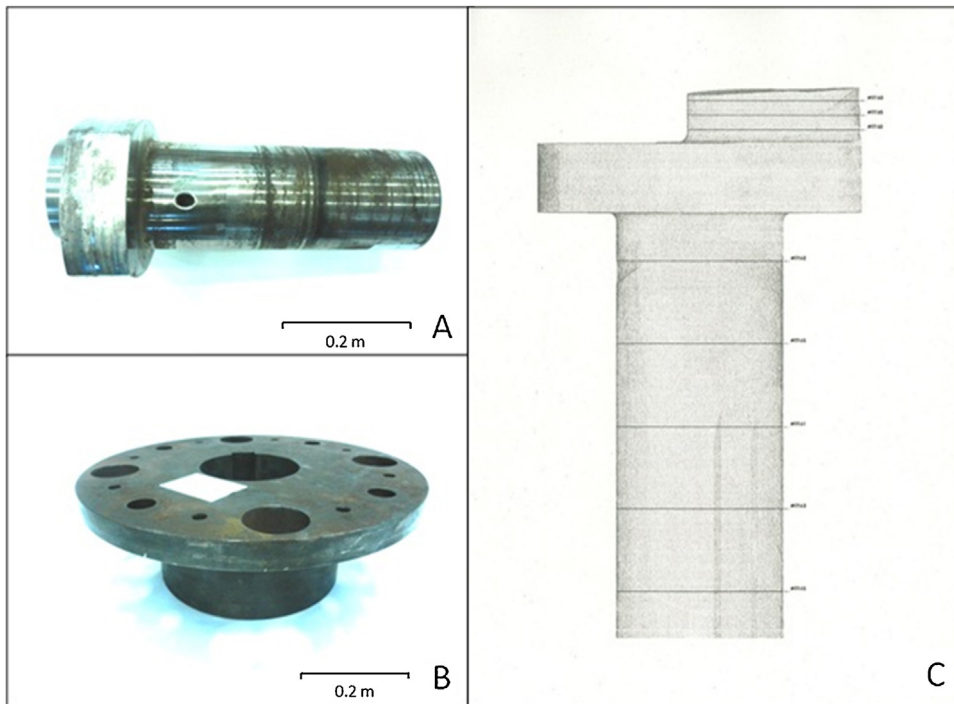
Fig. 1a and b shows a section of the crankshaft and hub in the as-received condition. The section of crankshaft consisted of a saw cut shaft section with a nominal diameter of 180 mm connected, via a crank web, to a longer shaft section with a machined end of nominal diameter 170 mm. A crack was evident in the longer shaft section.

The longer shaft section contained a keyway and a lubrication port. The keyway was 240 mm in length, with a depth of 17 mm and a width of 45 mm. The visual appearance of the crack, from the surface of the crankshaft, suggested that it may have propagated from the keyway spiralling along the section of shaft, in one direction, for 200 mm rotating through roughly 225 degrees of the shaft's circumference.

Fig. 1. (A) Section of crankshaft as received, (B) hub as received and (C) laser scan of the crankshaft showing the diameter measurements.

Deformation marks, including scoring and galling, were observed across the majority of the shaft's surface. An 18 mm wide circumferential band of plastic deformation, consistent with galling, was observed 290 mm from the shaft's machined end.

The crankshaft and internal bore of the hub were scanned using a Romer Absolute Arm 7525SI. Laser scanning was undertaken to verify that the shaft and hub were concentric, and to determine if an out of balance force played a role in the shaft's failure. It was found that the shaft was concentric to within 0.04 mm along its length, i.e. there was no taper, Fig. 1c. The internal bore of the hub had a slight ovality of 0.058 mm.

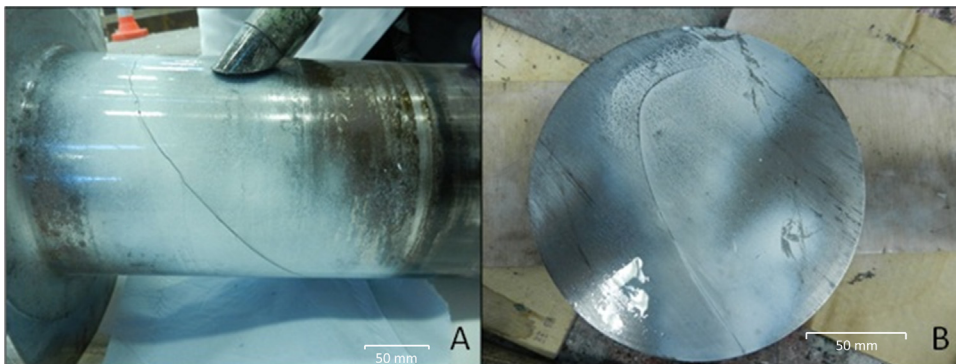
Magnetic particle inspection (MPI) was used to determine the extent of cracking and to identify the location of the crack tips on the surface of the crankshaft, Fig. 2a. It could be inferred from MPI that the crack extended for the majority of the shaft's length, rotating through approximately 225 degrees of the shaft's circumference. The crack tips, at the surface of the

Fig. 2. (A) MPI of crankshaft surface showing extent of cracking and (B) section through crankshaft, showing extent of cracking.
