# Case Studies in Engineering Failure Analysis

# Failure analysis of a polymer centrifugal impeller

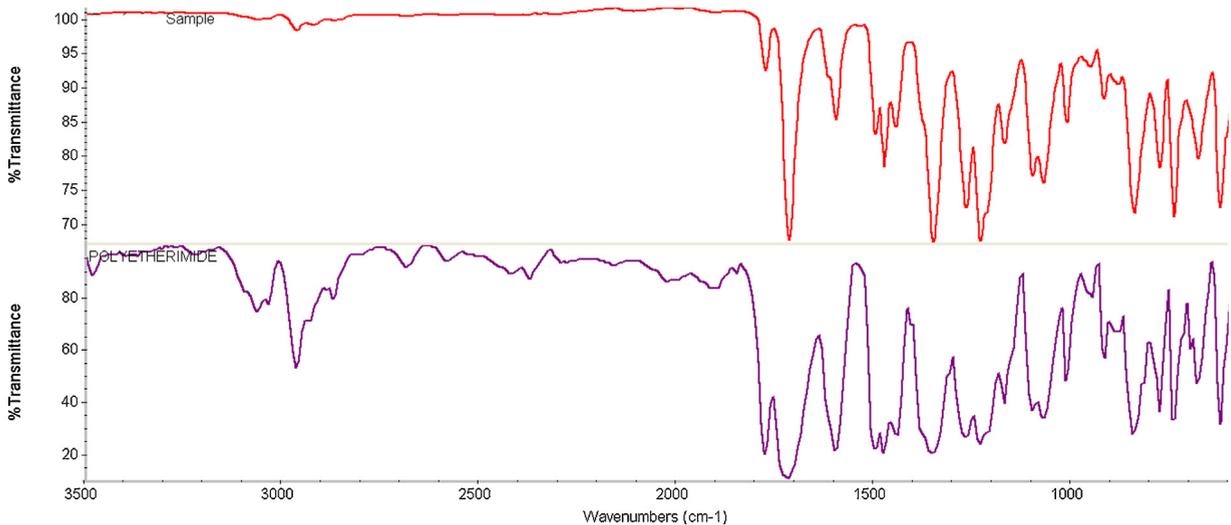
Fig. 1. Fourier transform infrared spectroscopy of impeller provides a spectrum match with library database that indicated a polyetherimide material.
