## Case study

## Fracture analysis of U71Mn rail flash-butt welding joint

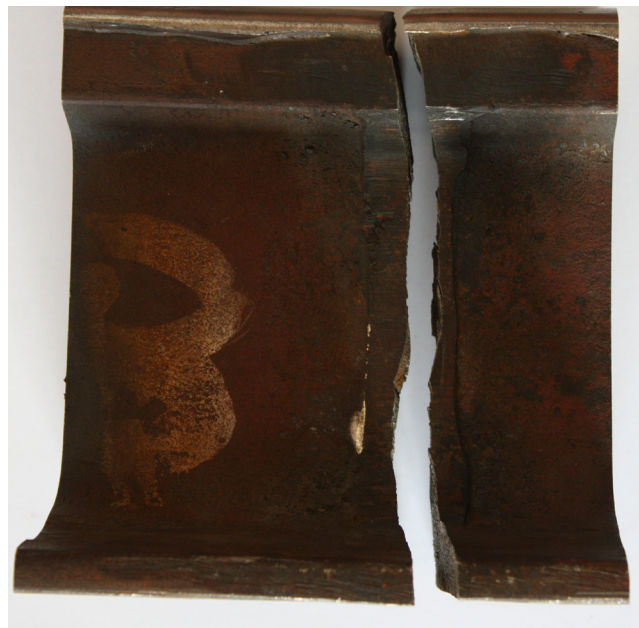
Fig. 1 shows the rail fracture position and the crack propagation shape. As shown in Fig. 1, the rail fracture happens at the flash-butt welding joint, and crack propagation shape is irregular curved.

Fig. 1. Rail fracture position and crack propagation shape.
