## Perforated mechanism of a water line outlet tee pipe for an oil well drilling rig

A corroded tee pipe belonging to a 10-in new separator water line outlet installed in an offshore oil well drilling rig was investigated. The configuration of the large corroded pit had the shape of an imperfect horse's hoof with a completely corroded interior and a honeycomb-like cavity. There is a badly corroded pit at the welded seam at the joint connecting the tee pipe and flange. The material strength of the tee pipe meets the requirement of ASTM-A234 Gr. WPR, but its chemical composition does not meet the stipulated requirements. A deformed streamline structure or twin crystal in the ferrite phase can be seen near the surface or sub-surface of the perforated corrosion puncture edge. The micro-hardness is also different from that of the original material. The SEM results show that the puncture appears to have been a mode of quasi-cleavage fractures with secondary cracks along the direction of the crystal grain; thus, the failure has the features of mechanical and chemical corrosion. The corroded surface contains high amounts of O, C, and N, as well as S, Cl, Si, Na, Mg, Al, K, Ti, etc., all o

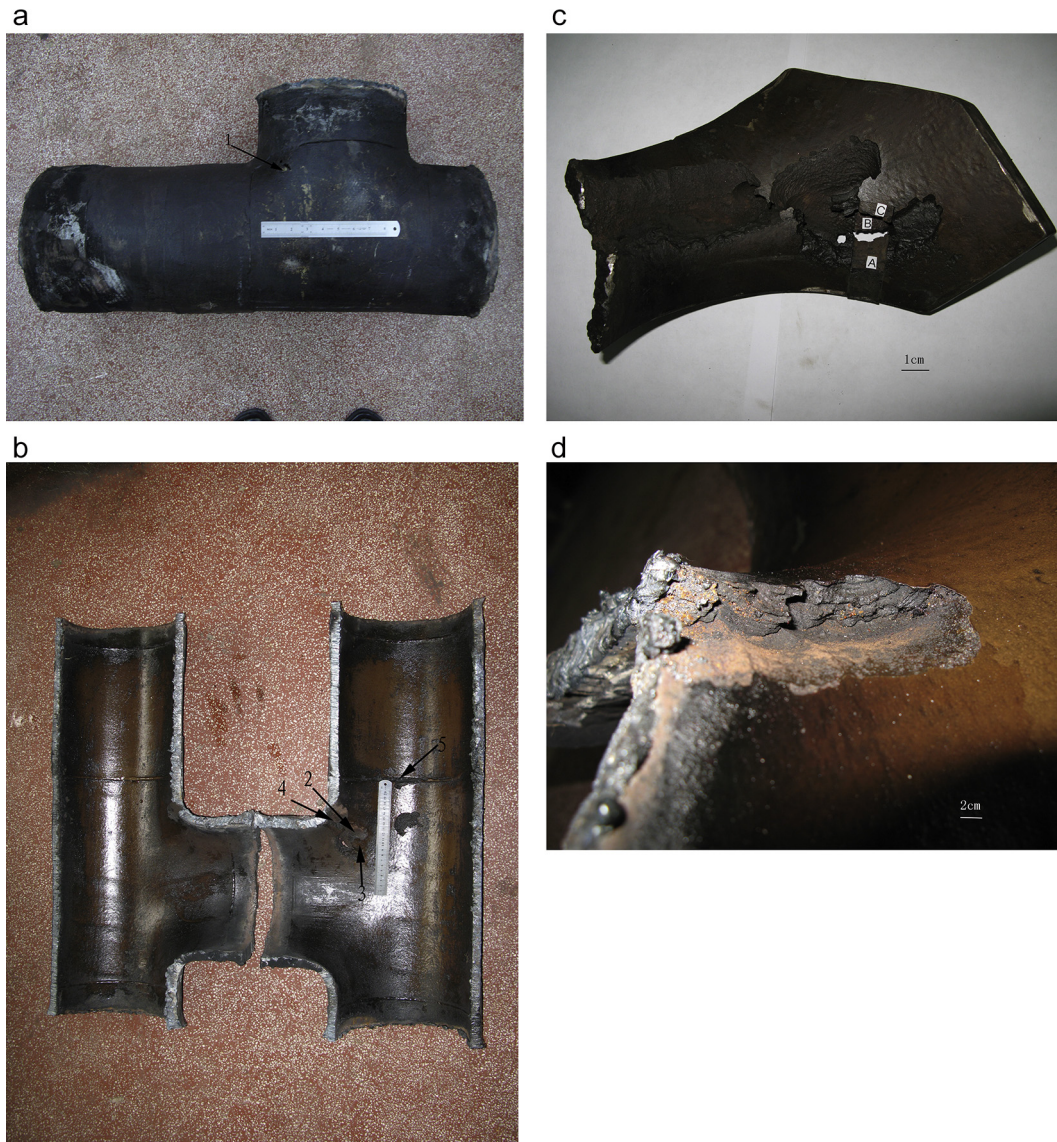
Corrosion in oil drilling and transport pipelines is very common [1–7]. The perforated pipe examined in this study is a tee pipe, which is a 10-in new separator water line outlet installed on an offshore oil well-drilling rig, as shown in Fig. 1, where Fig. 1(a) shows its exterior, Fig. 1(b) shows its interior and Fig. 1(c) and (d) shows its corroded areas.

The tested tee pipe was installed on an offshore oil well-drilling rig, and the fluid flowing in the pipe was the oil-containing sewage produced after crude oil has been separated. The pipe was perforated due to corrosion after only 6–12 months of use. The perforation in the pipe is a small-size hole near the pipe joint corner and has a simple shape (arrow 1); the corroded area, however, is relatively large (arrow 2).

Fig. 1. Interior and exterior of the perforated tee pipe. (a) Exterior; (b) interior; (c) interior of the corroded cavity; (d) interior of location "3" in Fig. 1 (b).
