## Metallurgical investigation of wire breakage of tyre bead grade

Piyas Palit\*, Souvik Das, Jitendra Mathur

R&amp;D and Scientific Services, Tata Steel Limited, Jamshedpur 831 001, India

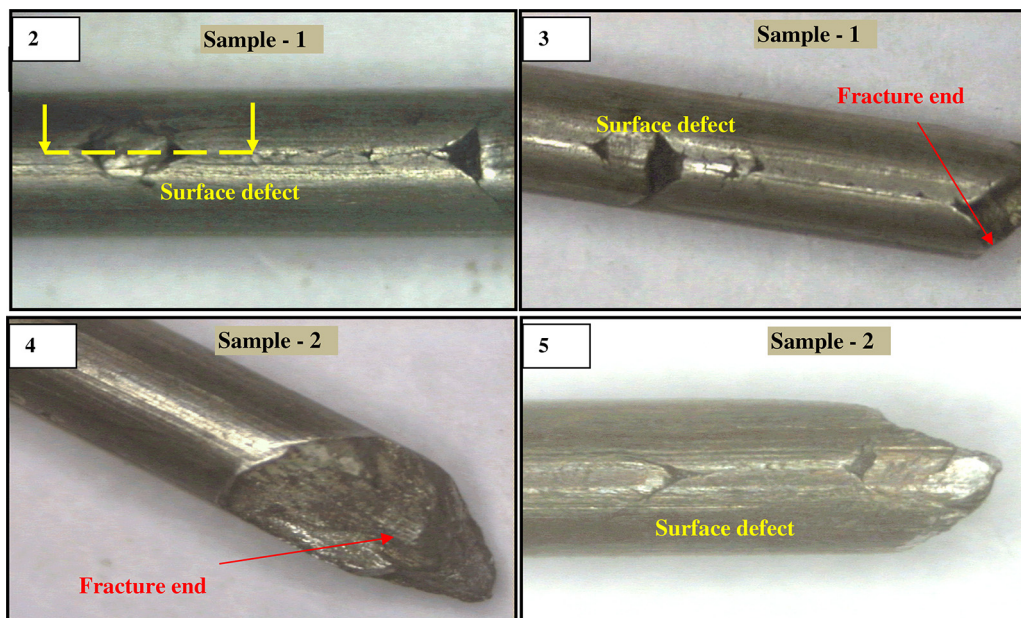
Two pieces of breakage wire samples were collected from the drawing mill for investigations. The samples were cleaned with acetone to remove dirt for visual examination prior to metallographic sample preparation. Visual examination is carried out in stereoscope. Surface appearance of the defects in all wire samples was of similar in nature. The fracture surface revealed finger nail type (Figs. 4 and 5). Crow feet like defects including button like surface abnormalities were observed on

the broken wire samples. The defect was observed near the fracture end and which was very much localized in nature (Figs. 2 and 3).

Figs. 2–5. (2, 3) Closer view of surface defects of failed wire samples #1. (4, 5) Closer view of surface defects of failed wire samples #2.
