Case Studies in Engineering Failure Analysis

Analysis of abnormal fatigue failure of forklift forks

George Pantazopoulos*, Athanasios Vazdirvanidis, Andreas Rikos,
Anagnostis Toulfatzis

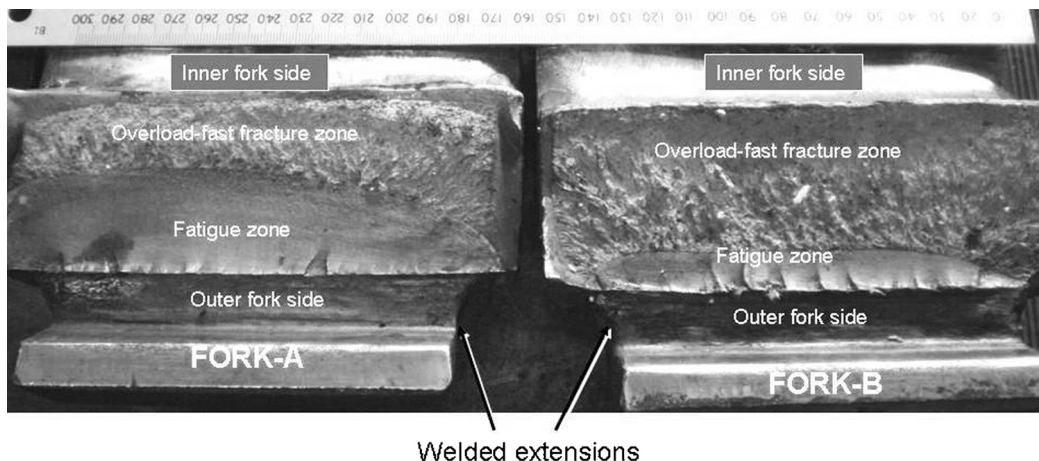
Fractographic evaluation constitutes a powerful analytical technique dedicated to identify the fracture mechanism(s) in the context of failure analysis of machine components, see also Ref. [6]. The overall view of the fracture surfaces of both forks is presented in Fig. 1. The macroscopic fracture patterns acquired during visual examination suggest the occurrence of bending fatigue loading mechanism (Figs. 1 and 2). The orientation of fatigue zone advocates that crack initiation occurred at the outer fork side, which constitutes the designed compression zone. Detailed assessment of fracture surfaces identified some characteristic features of fatigue failure: (i) beach marks which constitute fatigue crack front progression marks and (ii) ratchet marks which are signs of multiple crack initiation due to high stress concentration (Fig. 2). Fractographic features of fatigue fractures are also presented in Refs. [7–9]. The exact fatigue mechanism is rather consistent to unidirectional bending while the extent of fatigue zone is likely typical for moderate to high loading conditions. Macro-fractographic observations indicate that Fork A is rather the primarily failed component, resulting in unbalanced stress state concentrated to Fork B, where fatigue zone seems to be developed in a lesser extent (see Figs. 1 and 2).

Fig. 1. General view of the fractured forklift forks.
