# Case Studies in Engineering Failure Analysis

# Failure analysis of a bridge crane shaft

Failure analysis of a shaft used in a bridge crane has been carried out. The shaft fractured in the keyway with evidence of fatigue. Chemical analysis, micro-structural characterization, fractography, hardness measurements, and finite element simulation were used for the analysis. The microstructure was predominantly tempered martensite; large amounts of oxides, micropores, and manganese sulfide inclusions were found. The geometry of the keyway also promoted the initiation crack because the width and height were erroneously designed. It was concluded that all these factors produced fatigue failure. It is recommended to first guarantee the chemical composition and microstructure of the material. Secondly, use magnesium or calcium additions in the steel casting process to obtain better shape control of inclusions and, finally, accomplish the geometric parameters recommended by the standard to avoid high stress concentration factors.

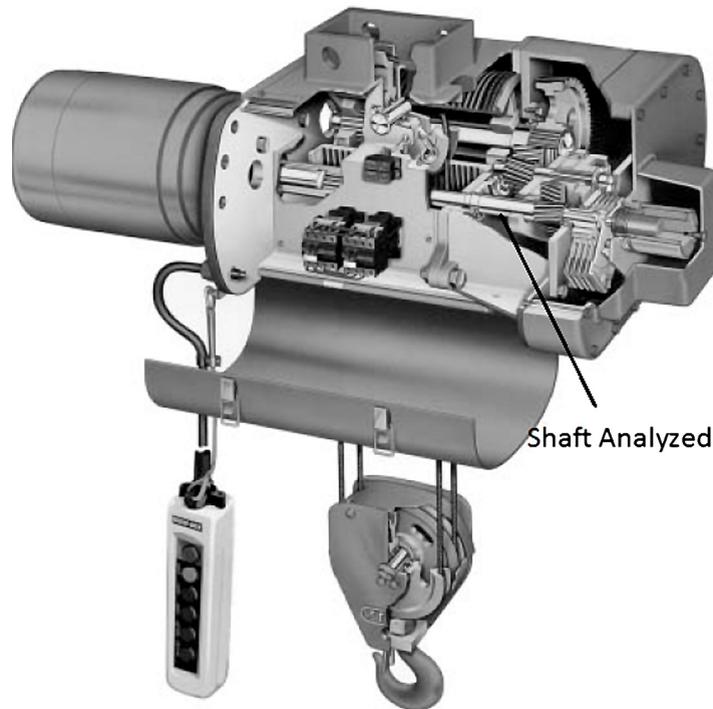
The shaft analyzed (replacement part) belongs to a bridge crane fractured after one year of operation. Fundamentally, the bridge crane system consists of an electric motor that transmits power to the shaft and this shaft transmits power to a reducer gearbox; a representation of the system is shown in Fig. 1. The keyway connects the system's brake. According to the material specification provided by the manufacturer, the material is an AISI 4340 steel normalized and tempered. Engine power is 3.73 kW and operates from 600 to 1800 rpm.

Fig. 1. Bridge crane and shaft analyzed, adapted from [9].
