Case study

Fractography of a neck failure in a double-modular hip implant

Jason J. Williams, Nikhilesh Chawla*

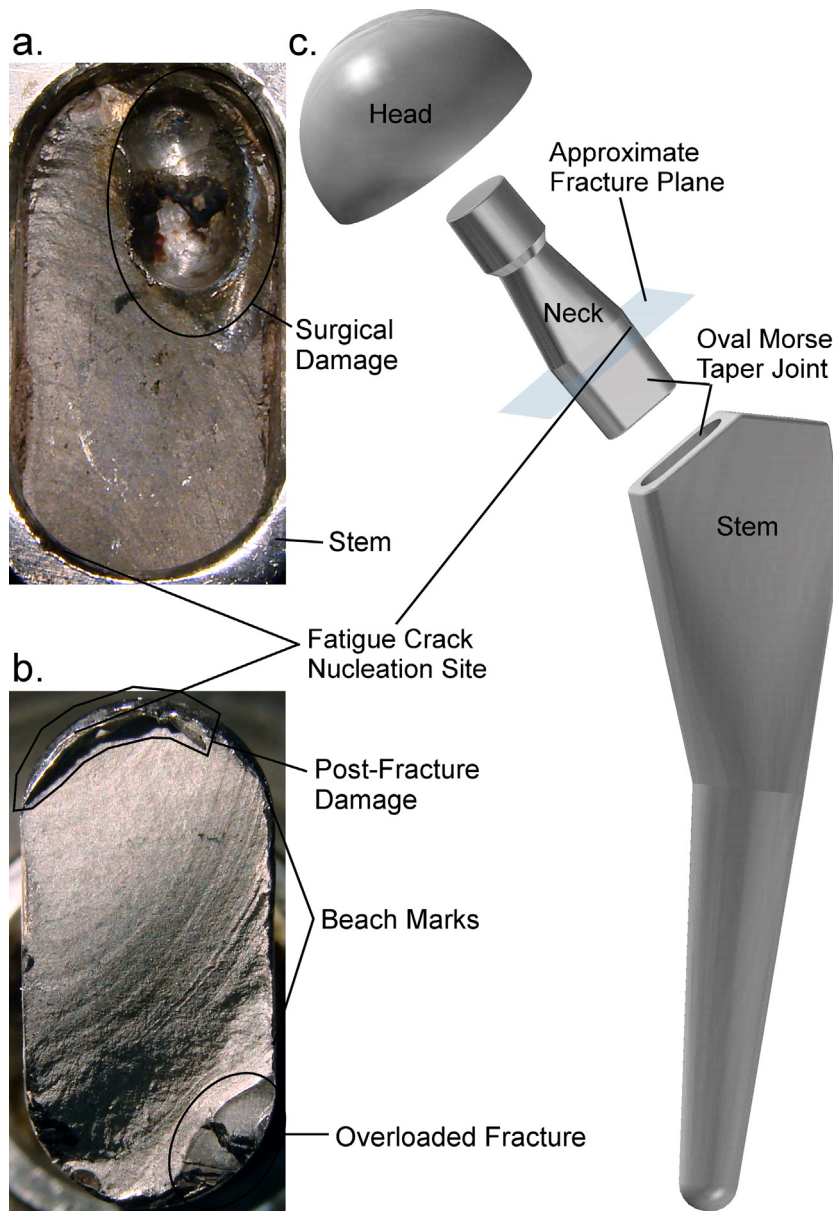
Fig. 1 shows optical photographs of both fracture surfaces, as well as a model of where fracture occurred in relation to the modular hip implant. After fracture, one piece of the neck remained inside the stem's female taper; the other piece remained

Fig. 1. (a) Optical photograph of the fracture surface of the neck that remained in the stem. The surgical damage was created by a tool used to remove the implant from the body. (b) Optical photograph of the fracture surface of the neck that remained attached to the head. Post-fracture damage occurred when the fractured neck slid across the inside of the stem's taper surface. (c) Exploded model of the modular hip implant, showing where neck fracture occurred. Both the neck and stem were made of Ti–6Al–4V.
