Case study

Fatigue fracture of cutter blade made of high-speed steel

Beata Letkowska, Włodzimierz Dudzinski, Lukasz Konat

Wrocław University of Technology, Poland

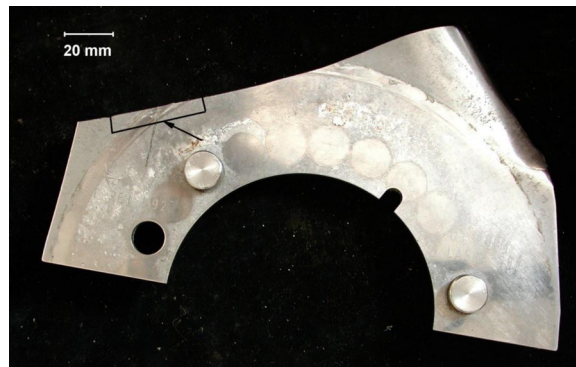
The subject of the analysis was the broken blade of cutter Ku 500VX that was used in meat processing. The aim of the study was to determine the failure cause and to give an answer how it could be avoided. General view of broken blade with marked area of the damage is shown in Fig. 1. The performed tests included hardness measurements, fractography analysis and metallographic studies using stereoscopic, light and scanning electron microscopes.

A general view of the broken blade is shown in Fig. 1. Sample for testing was taken near to damage from the marked area (Fig. 1). The broken blade was made of high-speed tool steel typically used for cutting tools. The structure was made of

Fig. 1. General view of the broken blade. The arrow indicates the place where sample was taken for testing and indicates the place where the inscription (number "1") was made with engraving tool.

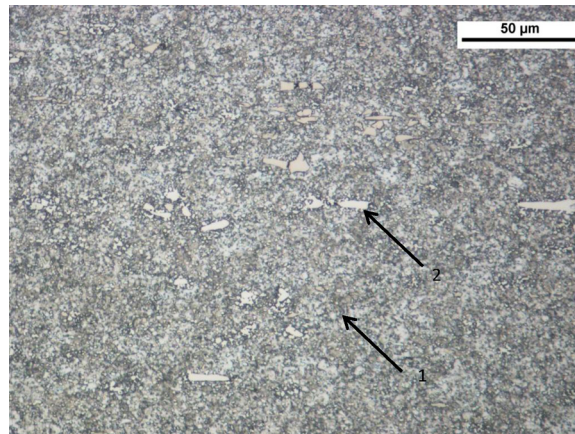
martensite matrix with precipitates of fine secondary carbides and undissolved primary carbides (with a light intensity of banding). No tendency to form carbides grid was observed (Figs. 2 and 3). This is a typical structure for properly heat treated high speed tool steels. The average hardness value was 456 HV10 (46 HRC).

Fig. 2. Structure of martensite matrix with precipitates of fine secondary carbides [1] and undissolved primary carbides [2]. Light microscopy, etched with Mi19Fe.

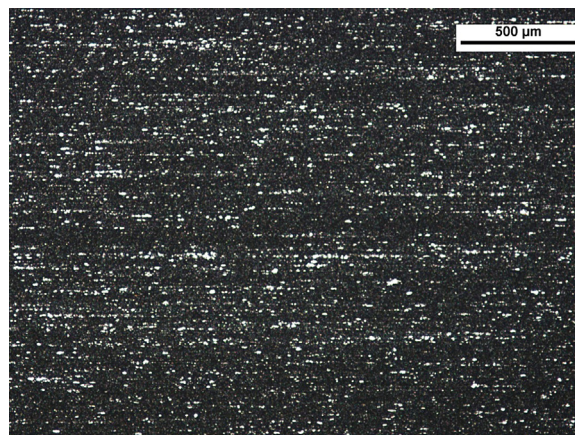
Fig. 3. The magnified part of area presented in Fig. 2. Structure of martensite matrix with precipitates of fine secondary carbides. No tendency to form carbides grid was observed. Light microscopy, etched with Mi19Fe.
