Failure analysis of axle shaft of a fork lift

Souvik Das^{*}, Goutam Mukhopadhyay, Sandip Bhattacharyya

R&D and Scientific Services, Tata Steel Limited, Jamshedpur 831 001, India

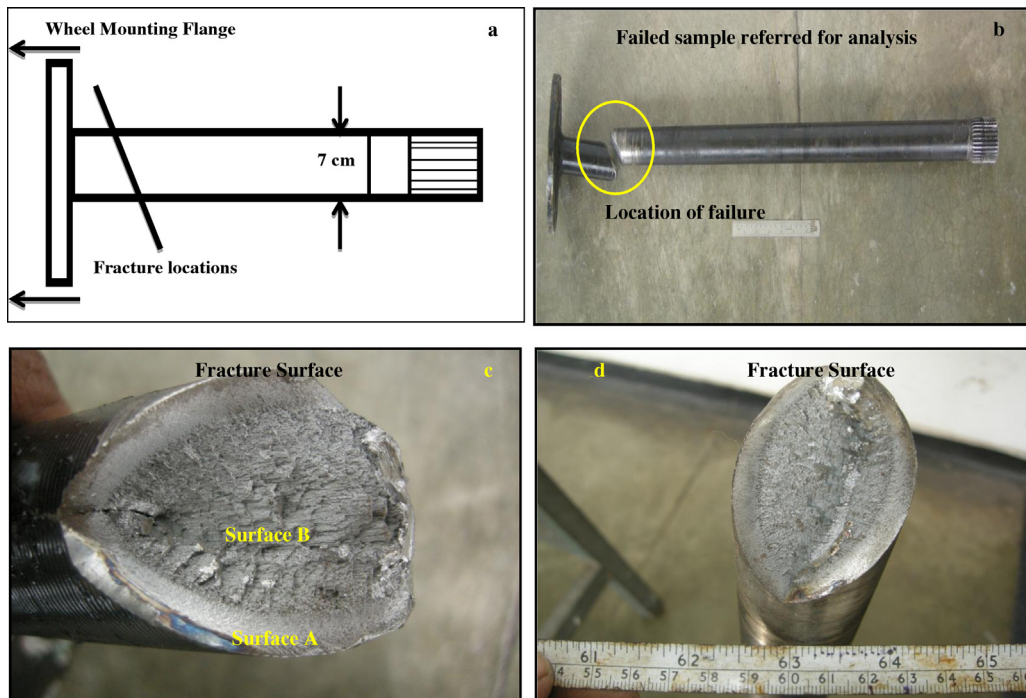
Fig. 1a is a schematic illustration of the rear axle shaft showing the approximate location of the fracture near the wheel mounting flange. A photograph of the section received for analysis is shown in Fig. 1b. The axle shaft failed in shear mode at almost 45° to the longitudinal direction under torque [2,3]. It is observed that the fracture surface consists of two distinct regions: (i) a relatively smooth annular region at periphery marked as A where the fracture was initiated, and (ii) a rough core marked as B (shown in Fig. 1c).

Fig. 1. (a) Schematic illustration of the rear axle shaft showing the approximate location of the fracture near the wheel mounting flange; (b) general view of the failed axle shaft referred for analysis; (c) closer view of the fracture surface of the failed component.
