A failure study of a locking compression plate implant

Nirajan Thapa^a, Michael Prayson^b, Tarun Goswami^{a,b,c,*}^a Department of Biomedical, Industrial and Human Factors Engineering, Wright State University, Dayton, OH 45435, USA^b Orthopaedic Surgery, Sports Medicine and Rehabilitation, Wright State University, Dayton, OH 45435, USA^c Institute of Materials Science and Welding, Graz University of Technology, Kopernikusgasse 24/I, 8010 Graz, Austria

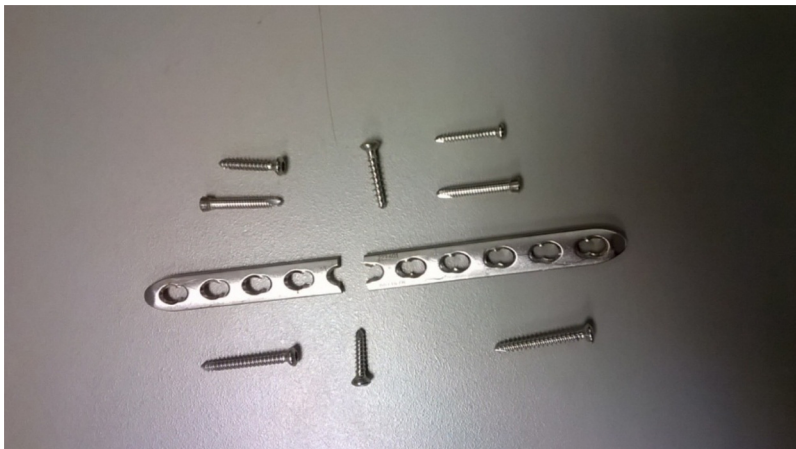
The retrieved device is shown in Fig. 2. The device consisted of plate, separated in two pieces from the mid-section. There were 8 screws of the different sizes. Among them two were locking screws and others non-locking screws. Total length of the

plate was 137.5 mm. The length of the screws were; 16.5, 20.5, 24.5, 28.5, and 30.5 mm, respectively. The plate was 3.5 mm thick, Fig. 2.

Visual inspections revealed scratches on the surface of the plate. Some rusting also was visible.

Fig. 2. Locking compression plate and Screws submitted for this study.
