Case Studies in Engineering Failure Analysis

Case study

Leg weld fatigue cracks in anhydrous ammonia nurse tanks

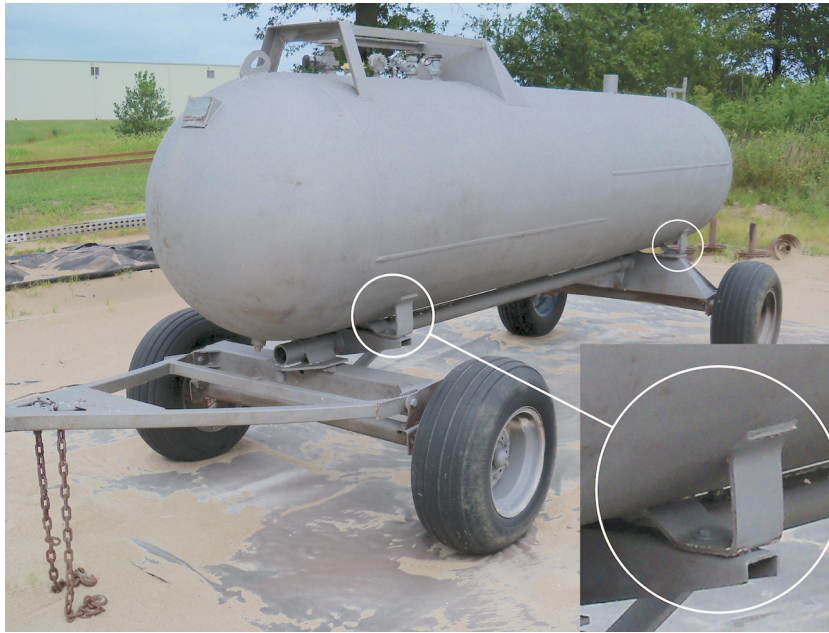
Fig. 1. Anhydrous ammonia nurse tank mounted on running gear. Inset shows that the leg attachment brackets are welded directly to the tank body to connect the tank to the running gear.

In a 2012 incident near Casey, Iowa, USA, a nurse tank rapidly vented its entire contents from a fracture initiated at a crack on a leg weld. A nearby worker escaped injury by running to his truck and driving upwind away from the expanding ammonia cloud, which destroyed more than a hectare of corn plants. That incident occurred while the authors were performing an extensive study of SCC in nurse tanks [9–11] that included examination by side-angle ultrasound of all welds on each of 532 used nurse tanks. The great majority of the 3326 indications detected by examining those tanks appeared in or near the longitudinal and circumferential welds used to fabricate the tanks from plate (Fig. 2), but the measurements also revealed that more than 9% of the tanks showed indications in the heat-affected zones near the tanks' leg welds (Fig. 1 inset). These leg weld indications are the subject of this study.
