Case Studies in Engineering Failure Analysis

Premature failure of dissimilar metal weld joint at intermediate temperature superheater tube

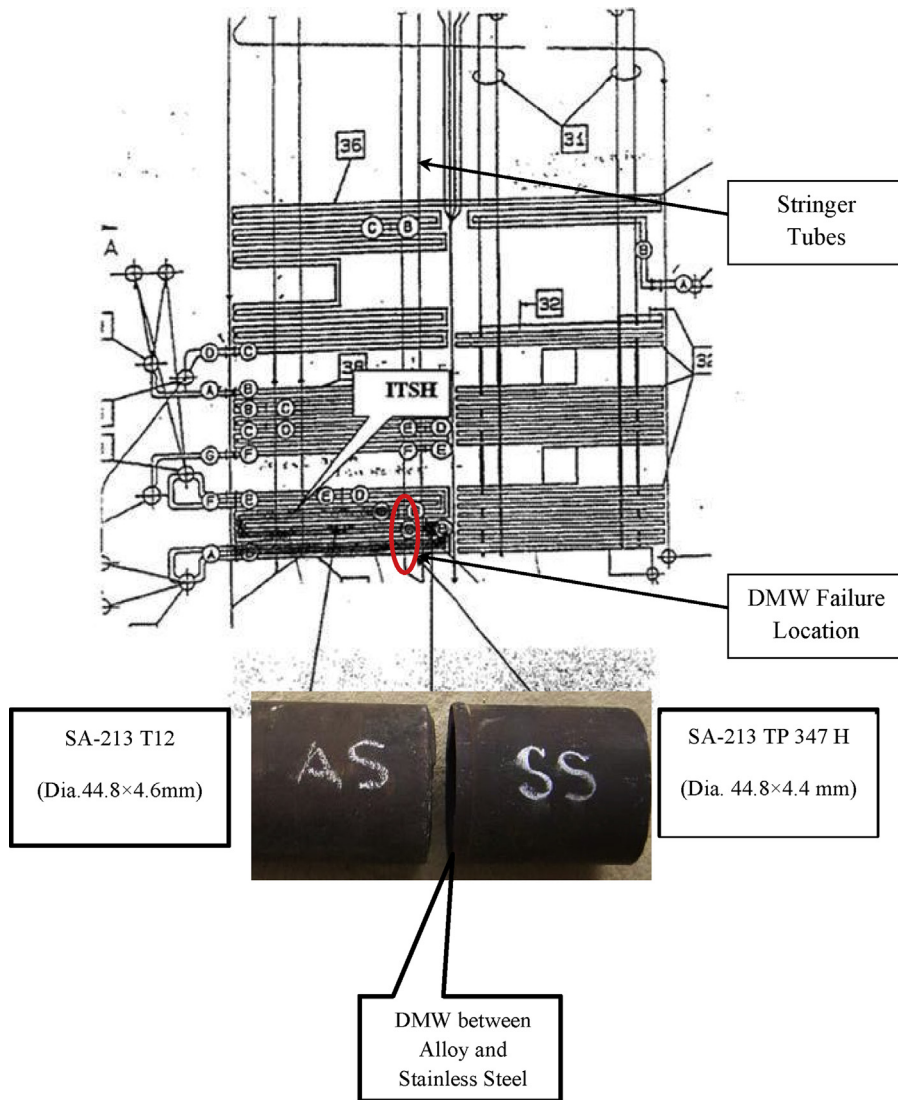
Fig. 1. Schematic diagram showing the failure location in the ITSH area.

However, premature failure of DMW occurred only after 8 years of operation at ITSH tube. All superheater tubes are drainable and horizontal type. Part of ITSH is located in second pass and the second part is located in the furnace where it receives part or all of heat by radiation. Failure location is indicated in Fig. 1 and Boiler specifications including ITSH material information are summarized in Tables 1 and 2.
