Engineering Failure Analysis

Failure and thermo-mechanical stress analysis of the exhaust valve of diesel engine

Lucjan Witek

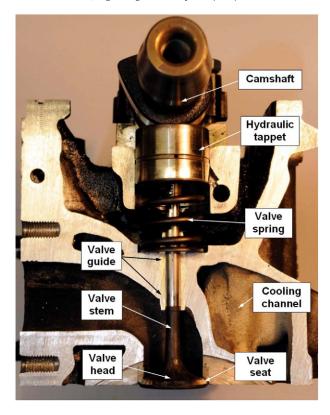
Fig. 1. Exhaust valve assembled in the head of a diesel engine (cross-section of engine head in which the fracture of valve occurred).
