Gearbox fault diagnosis of high-speed railway train

This paper is aimed at detecting crack faults of a lubricant level viewport and upper viewport of a high-speed railway train gear box operating for a repair cycle from 200,000 to 300,000 km. This paper reports a series of test results involving vibration and dynamic stress tests to identify the occurrence of partial resonance and stress concentration points of the gear box structure under external excitation tests. The results of the tests were confirmed using both finite element analysis and modal analysis. This paper also describes the causes of the crack fault on the gear box body and provides a comprehensive analysis of the causes of the gearbox crack. With this approach the faults on the high-speed train gearbox structure were identified and corrective solutions suggested.

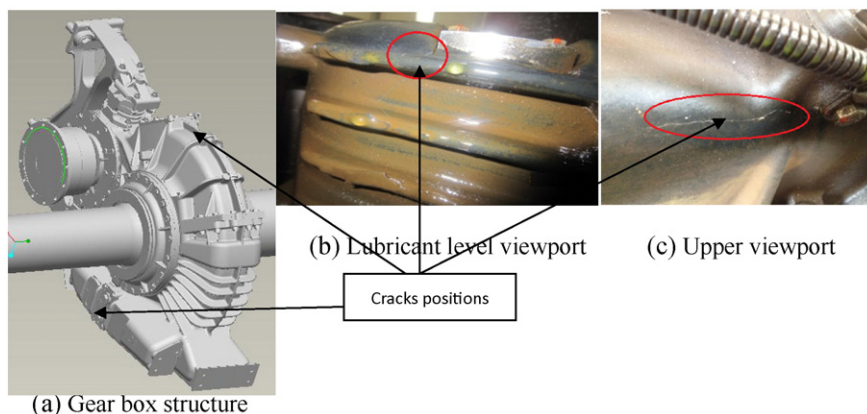
Fig. 1. Locations of cracks on gear box body.

In order to understand the causes of gearbox body cracks, vibration tests were conducted on the gearbox of operating trains in service and relevant vibration features of the gear box body were analyzed. The measurement of structural features in the vibration test was to obtain the condition of the gear box body by deploying acceleration sensors on the gear box body at the box axle end and the gear box end. The positions of gear box body cracks are shown in Fig. 1, where Fig. 1(a) indicates the positions of the cracks, Fig. 1(b) and (c) show the shape of the cracks, respectively. The propagation of gear box body cracks are clearly shown in the figures.
